PLACES OF CONTESTATION:
A STUDY OF PUBLIC BUILDINGS AT RÍO VIEJO
ON THE PACIFIC COAST OF OAXACA, MEXICO

Cuauhtémoc Vidal Guzmán

A thesis submitted to the
Faculty of the Graduate School of the
University of Colorado in partial fulfillment
of the requirement for the degree of

The purpose of this thesis is to study the building sequence of the north central part of the acropolis of Río Viejo, a site on the Pacific coast of Oaxaca. In particular, I focus on two construction phases of a public building dated to the late Terminal Formative labeled Structure 8-sub 1 and Structure 8. Contextualizing these edifices within the construction program that erected Río Viejo's acropolis affords the opportunity to assess how they were entangled in the social context of the first regional polity in the area. To this end, I discuss three themes: 1) how the construction of Structure 8-sub 1 and Structure 8 was the result of collective works that actively created and redefined the community; 2) The formation of restricted areas as an elite strategy to try to appropriate formerly communal space; 3) the diversity of termination rituals that "closed" the acropolis. I conclude by arguing that public ar

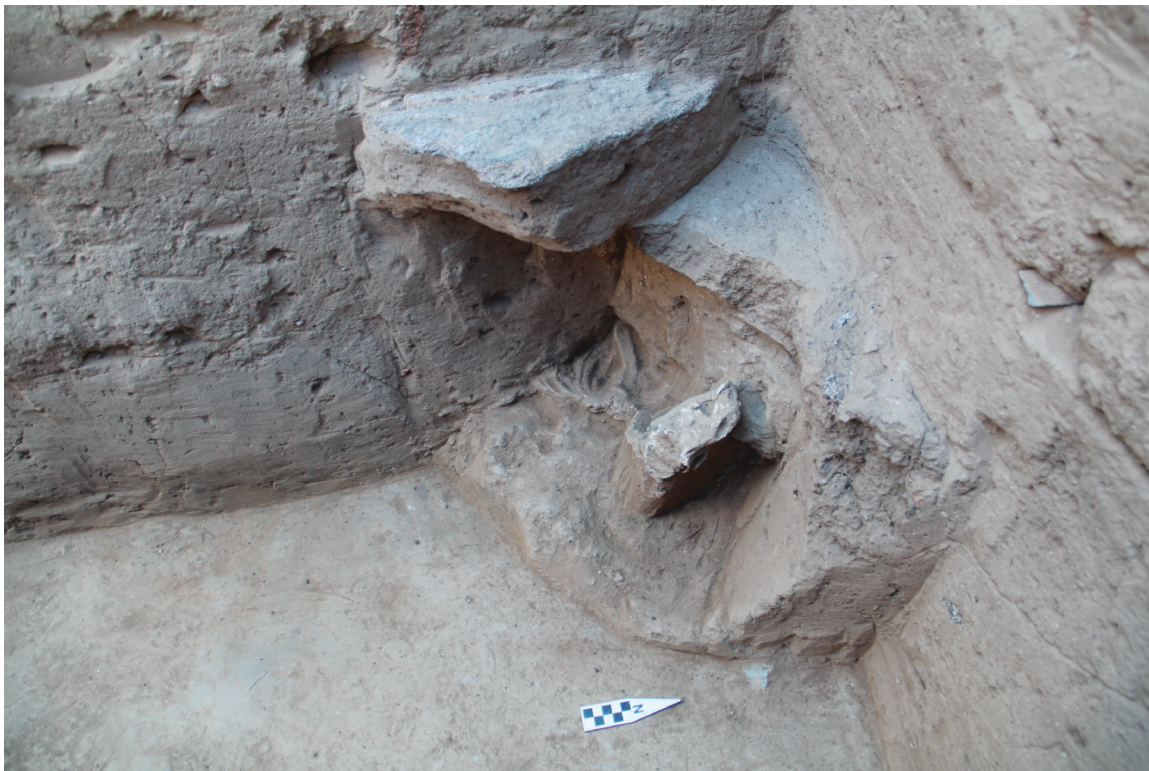
Probably during the same termination rituals, pit F165, found in Units 36XX and 36YY, was dug and filled with a sediment rich in ceramic sherds. Within feature F165, two medium sized slabs were found, possibly the opening of a pit dug into F165 where the articulated skeleton of a feline was found (F162) (Figure 3.21). It is possible that the feline was placed as part of the same termination/abandonment program. If indeed F162 represents a termination cache, the feline is the only offering dated to the Terminal Formative found within the confines of Op. RV13 F.

Figure 3. 21 Offering F162 containing the articulated skeleton of a feline
