Archaeology and Conservation of the Middle Phrygian Gate Complex at Gordion, Turkey

SEMİH GÖNEN, RICHARD F. LIEBHART, NAOMI F. MILLER,
AND ELSPETH R. M. DUSINBERRE

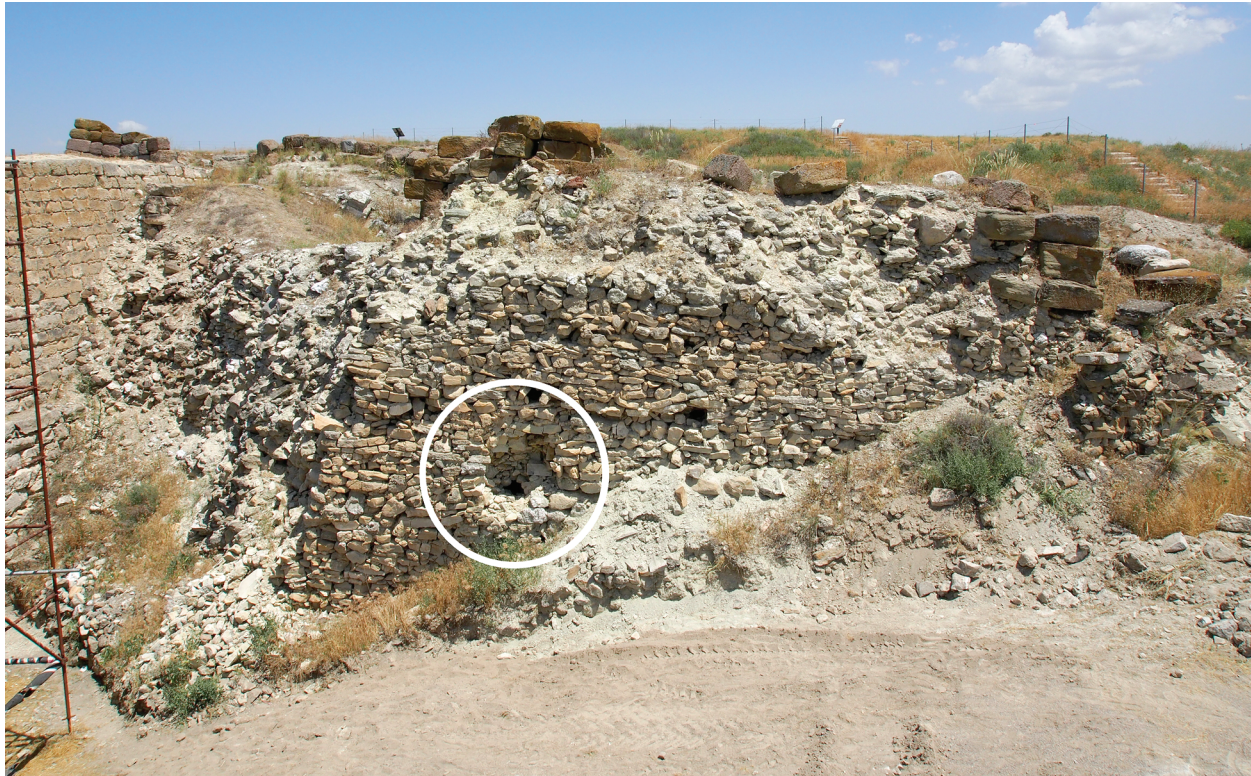
Fig. 19. View looking north toward the rubble fill: The circle indicates the location of the 2015–2016 collapse in the main face of the rubble. At the top above that area are the precariously situated blocks of the North Court of the Middle Phrygian Gate. To the left is the too-steep rubble slope resting in part against the east outer wall of the North Bastion of the Early Phrygian Gate Building. (Photo by S. Gönen)

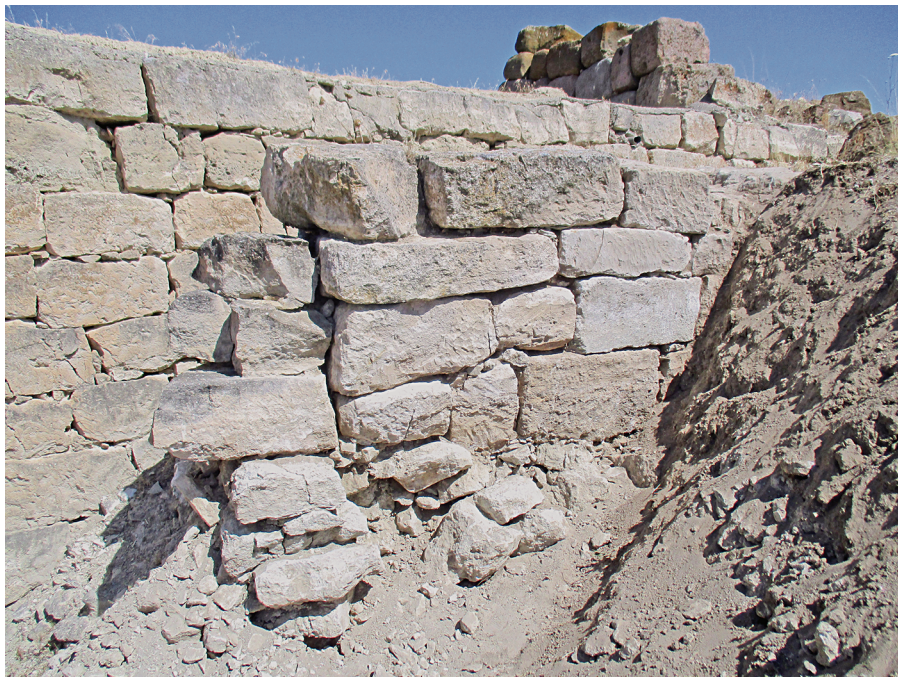
Fig. 21. Part of the Middle Phrygian wall foundations, resting on and originally surrounded by the rubble fill, looking northwest. The outer face of the Early Phrygian Gate's North Court is visible in the background. (Photo by S. Gönen)

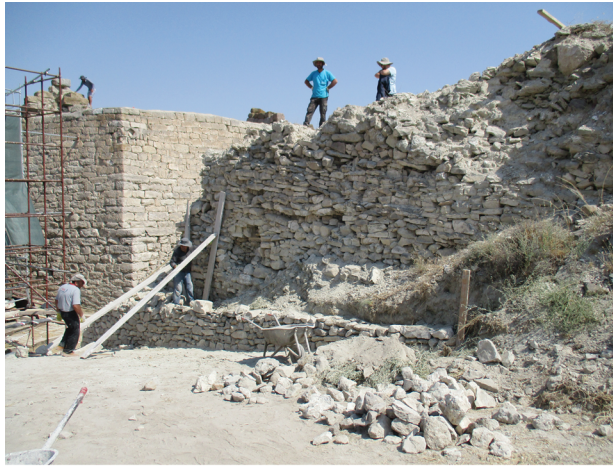
¹³ For instance, Elizabeth Vintzileou (2008) comments that the cracking load of timber-reinforced masonry is significantly higher than that of unreinforced masonry, and timber ties allow for substantial diagonal cracks to open without the masonry disintegrating.
