Brief communication: Observations of a glacier outburst flood from Lhotse Glacier, Everest area, Nepal

Abstract. Glacier outburst floods with origins from Lhotse Glacier, located in the Everest region of Nepal, occurred on 25 May 2015 and 12 June 2016. The most recent event was witnessed by investigators, which provided unique insights into the magnitude, source, and triggering mechanism of the flood. The field assessment and satellite imagery analysis following the event revealed that most of the flood water was stored englacially and that the flood was likely triggered by dam failure. The flood's peak discharge was estimated to be $210 \text{ m}^3 \text{ s}^{-1}$.

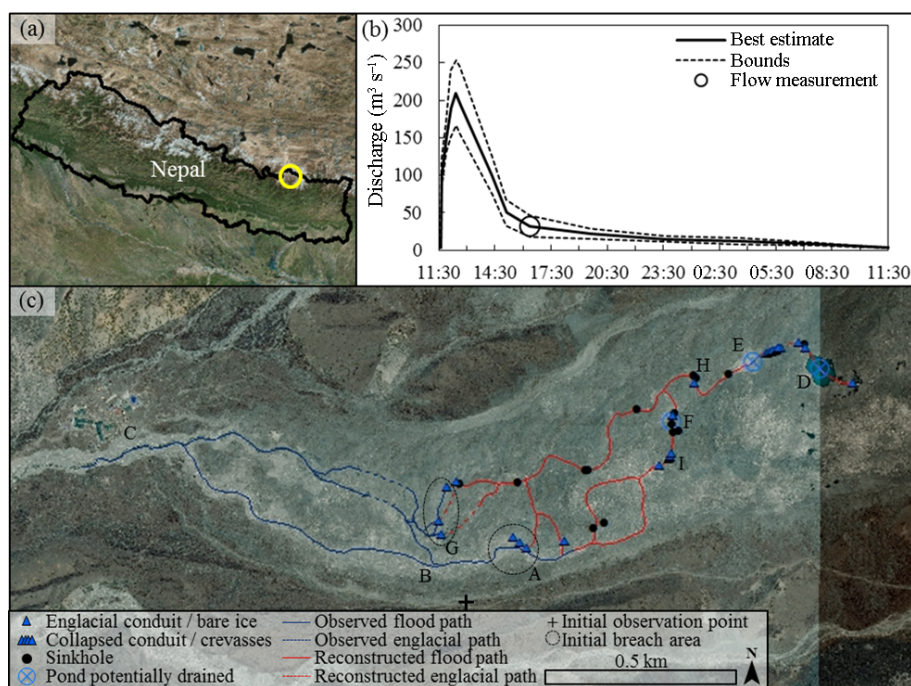
Figure 1. (a) Location of Lhotse Glacier in Nepal, (b) hydrograph of the glacier outburst flood from Lhotse Glacier on 12 June 2016, and (c) map of observations and the reconstructed flood path down to the village of Chukhung, with letters corresponding to key features in Fig. 2.

Lhotse Glacier (27°54'12" N, 86°52'40" E) is an avalanche-fed, debris-covered glacier that extends 8.5 km from the peak of Lhotse at 8501 m to the glacier's terminus at 4800 m (Fig. 1a). The lowest 3.5 km of the glacier is relatively stagnant and contains many supraglacial ponds. The upper 4 km, located beneath the headwall of Lhotse, is still quite active (Quincey et al., 2007), which can be seen by its highly crevassed features and its transient supraglacial ponds indicating frequent changes in the glacier's subsurface (Watson et al., 2016). Lhotse Glacier is one of the few glaciers in the region that lacks a steep bounding terminal moraine; instead, the terminus of the glacier is relatively steep ($>6^\circ$), which facilitates the drainage of supraglacial ponds and prevents the development of a large proglacial lake (Quincey et al., 2007). As these supraglacial ponds drain and fill, they can cover up to 1.3–2.5 % of the debris-covered glacier's surface at any time (Watson et al., 2016). Speleological surveys conducted at Lhotse Glacier found that cut-and-closure mechanisms and the exploitation of high-permeability areas were the main contributors to the development of englacial conduits and the drainage of supraglacial ponds (Gulley and Benn, 2007).

Glacier outburst floods with origins from Lhotse Glacier occurred on 12 June 2016 and 25 May 2015. The 2015 event was reported by local community members, while the 2016 event was observed by the investigators from the southern lateral moraine of Lhotse Glacier (Fig. 1c). This provided a rare opportunity to photograph, record, and observe the outburst flood as it unfolded. Flow measurements at 16:22 LT, approximately 4 h after the peak discharge, were estimated from cross-sectional areas and float velocities using bundles of sticks in a relatively straight section of the channel below the village of Chukhung (27°54'03" N, 86°51'46" E). Average velocity for the flow measurements was estimated to be 85 % of the float velocity (Rantz et al., 1982). Uncertainty associated with the flow measurements comprised errors in river width (± 1 m), depth (± 0.3 m), float distance (± 1 m), and time (± 1 s). Peak flow was conservatively estimated using the same average velocity with cross-sectional areas derived from high-water marks.

At 11:40 on 12 June 2016, three landslide-like features began flowing almost simultaneously down a south-facing slope of Lhotse Glacier, followed by large amounts of discharging water from three apparent englacial conduits and one supraglacial stream (Fig. 1c, 2a). At the same time, approximately 200 m northwest of these landslide-like features, large amounts of sediment-laden water was observed to be discharging into the main channel from multiple englacial conduits and supraglacial channels (Fig. 2b). Around 12:10, an additional supraglacial torrent and two supraglacial streams, located up-glacier and to the east of the initial observations, joined the floodwater discharging from this initial area. The discharging water immediately began ponding and quickly breached the pond, allowing the floodwater to propagate downstream and join the pre-existing main channel in addition to creating a secondary channel down the southern lateral moraine (Figs. 1c, 2b). During this time, channel banks composed of ice and debris were severely undercut as the floodwater melted the surrounding ice as well.

The main channel continued to flow downstream until it re-entered englacial conduits (Fig. 1c), which created an "ice bridge" that allowed investigators to cross the secondary and main channel after the peak flow started subsiding around 12:26. At 16:22, discharge below Chukhung was measured to be $32 \pm 14 \text{ m}^3 \text{ s}^{-1}$. Peak discharge was estimated retroactively to be $210 \pm 43 \text{ m}^3 \text{ s}^{-1}$. This estimate is considered to be conservative since it uses average velocity measurements taken 4 h after peak discharge. Interestingly, this estimate agrees well with an empirical approach for predicting peak discharge based on glacier-bed area (Fountain and Walder, 1998), which predicts the peak discharge to be $38\text{--}1500 \text{ m}^3 \text{ s}^{-1}$ based on a glacier area of 6.825 km^2 for Lhotse Glacier (Arendt et al., 2015). A best-estimate hydrograph (Fig. 1b) was reconstructed based on the photos

of the water level at the ice bridge showing a peak flow of $210 \pm 43 \text{ m}^3 \text{ s}^{-1}$ at 12:26, followed by a gradual falling limb such that the discharge returned to normal conditions within 24 h. The shape and timing of the hydrograph are consistent with the 1985 glacial lake outburst flood from Dig Tsho (Vuichard and Zimmerman, 1987), although the peak flow from Lhotse Glacier was significantly smaller. Based on this hydrograph, the overall flood volume was estimated to be $2.65 \times 10^6 \text{ m}^3$ and $1.88\text{--}3.45 \times 10^6 \text{ m}^3$ for the estimated low and high bounds, respectively. Minimal damage was caused to the community of Chukhung, which community members credited to the recently constructed gabions (Fig. 2c). The main damage was the loss of a pedestrian bridge, an outbuilding, and small amounts of floodwater in the courtyard of one lodge. The Supplement provides footage of the observed events.

A detailed field assessment of Lhotse Glacier was conducted to reconstruct the glacier outburst flood by identifying potential flood pathways, englacial conduits, sinkholes, and drained ponds (Fig. 1c). Satellite imagery from 14 May 2016 revealed a sizeable supraglacial pond ($27^\circ 54' 20'' \text{ N}$, $86^\circ 53' 27'' \text{ E}$) with an area of 4900 m^2 located directly beneath a large bare ice face ($\sim 10\text{--}20 \text{ m}$) that was considerably smaller during our field assessment (Fig. 2d). This pond also had fine, wet sediment along its slopes in addi-

This ponded water likely entered a series of englacial conduits and potentially supraglacial pathways before entering another supraglacial pond located $\sim 200 \text{ m}$ down-glacier (Fig. 1c). This second supraglacial pond had similar indicators of having recently drained (Fig. 2e), although the satellite image does not show a large supraglacial pond. It is possible that meltwater filled the pond between the time that the satellite image was acquired and the glacier outburst flood. A collapsed englacial conduit was observed between these two ponds (Fig. 1c) in addition to a series of sinkholes along with an entrance to an englacial conduit located immediately downstream of the pond (Fig. 2h). Based on recently uprooted and displaced alpine shrubs, the flood appeared to continue downstream, where it branched into multiple paths (Fig. 1c). The southern branch appears to have entered a third supraglacial pond (Fig. 2f), which had similar indicators and large sinkholes. Downstream of this third pond was a small valley that was littered with areas of clean ice and deep crevasses (Fig. 2i). It appears that this supraglacial pathway and englacial conduits fed into the flood torrent that joined the initial discharge at 12:10 (Fig. 1c). The other branch showed signs of supraglacial and englacial pathways in the

Potential triggering mechanisms for these glacier outburst floods include dam failure, the rapid drainage of stored lake water through hydraulically efficient pathways, and/or catastrophic glacier buoyancy. The sudden discharge observed during the 2016 event (Fig. 1b) suggests that the trigger was most likely dam failure or the rapid drainage of stored lake water, since catastrophic glacier buoyancy typically has a hydrograph with a more gradual rising limb (Fountain and Walder, 1998).

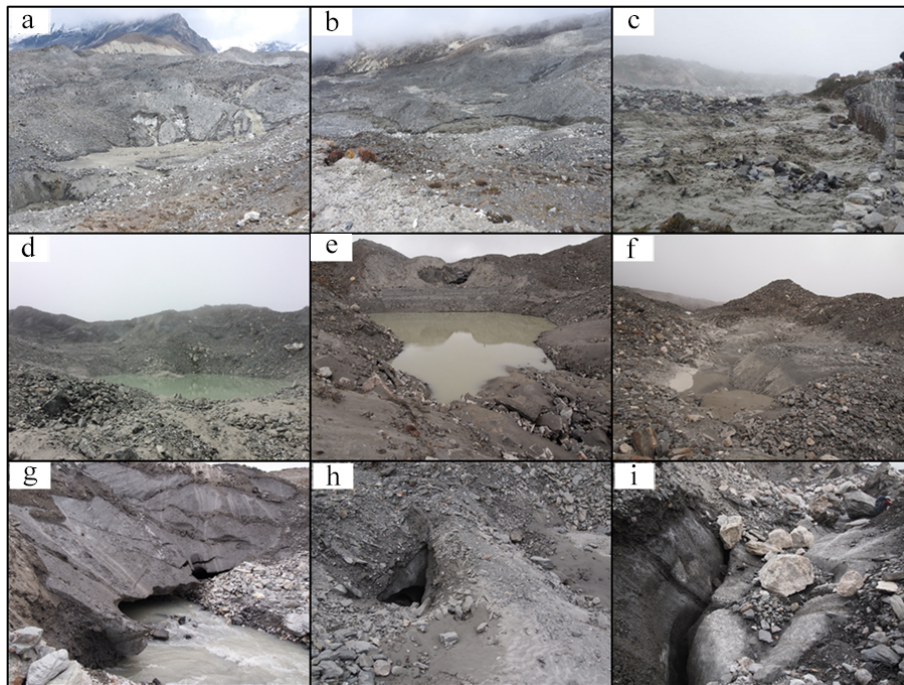
Figure 2. Key features of the glacier outburst flood from Lhotse Glacier: (a) subsurface and supraglacial flooding where the event was first observed; (b) main channels of flood path during the flood's peak; (c) flood undercutting the gabions at Chukung, at 14:19; (d) potentially drained pond with large bare ice faces behind it; (e) potentially drained pond with a collapsed englacial conduit behind it; (f) potentially drained pond with sinkholes; (g) meltwater exiting the glacier into the main channel via a large englacial conduit; (h) a vertical englacial conduit and sinkholes with wet, fine sediment indicating a drainage pathway; and (i) large vertical crevasses with clean ice likely from the supraglacial flood path.

form of bio-indicators, sinkholes, and englacial conduits as well, which appear to have contributed to the heavy flow that was observed discharging into the main channel as well (Fig. 2g).

The rapid drainage of stored lake water through hydraulically efficient pathways is another plausible triggering mechanism that commonly occurs for supraglacial ponds in the Everest region (Benn et al., 2012). Field observations of supraglacial ponds (Fig. 2d, e) revealed that there were englacial conduits located at the end of both of these lakes that likely helped facilitate their drainage. This link between the englacial conduits and supraglacial ponds is not surprising as near-surface water storage on glaciers can result from water accumulating in englacial conduits (Fountain and Walder, 1998). Once these ponds come in contact with an englacial conduit or a highly permeable layer, the warm pond water can cause significant internal ablation that helps facilitate the drainage of additional stored water. The drainage of supraglacial ponds that was observed for the 2015 and 2016 events supports this theory; however, as previously discussed, the drainage of supraglacial ponds alone likely accounts for a small fraction of the total flood volume.

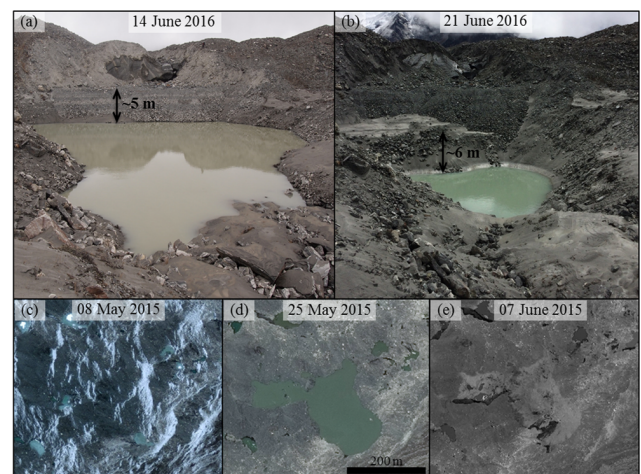
Figure 3. Images showing the temporal changes of supraglacial ponds (a, b) following the 2016 glacier outburst flood and (c, d, e) around the 2015 glacier outburst flood.

Satellite imagery provides unique opportunities to observe the contribution of supraglacial ponds to these glacier outburst flood events; however, it is important that this imagery is acquired immediately before and after the event as these supraglacial ponds experience large temporal and spatial changes (Fig. 3). In order to estimate the potential flood volume associated with the drainage of supraglacial ponds, an area-to-volume relationship was used (Cook and Quincey, 2015). Based on the change in areal extent between 14 May and 29 October 2016, the drained volume from the furthest supraglacial pond up-glacier (Figs. 1c, 2d) was $0.01 \times 10^6 \text{ m}^3$. This volume is 2 orders of magnitude less than the estimated flood volume of $2.65 \times 10^6 \text{ m}^3$, which suggests that the drainage of a single supraglacial pond contributes very little to the overall flood volume. In fact, if all of the 274 supraglacial ponds (0.21 km^2) that were present on Lhotse Glacier on 14 May 2016 drained completely, the potential flood volume would only be $0.52 \times 10^6 \text{ m}^3$. This pro-

sonal communication, 9 June 2015). Satellite imagery from 8 May, 25 May, and 7 June 2015 reveals a large supraglacial pond (0.036 km²) filling during the period 8–25 May and draining completely during 25 May–7 June (Fig. 3c, d, e). The drainage of this supraglacial pond could have contributed up to $0.17 \times 10^6 \text{ m}^3$ to the 2015 glacier outburst flood. Community members reported that the 2016 event was larger than the 2015 event. A similar outburst event was also reported to have occurred in early May 2016 in the vicinity of the “crampon put-on point” (5600 m) of Island Peak (6189 m) that damaged sections of the high and low base-camp regions (P. T. Sherpa, personal communication, 18 June 2016).
