**Seismic performance assessment of reinforced concrete structures:
quantifying the effects of damage and informal construction**

A thesis submitted to the
Faculty of the Graduate School of the
University of Colorado in partial fulfillment
of the requirements for the degree of
Doctor of Philosophy

Department of Civil, Environmental, and Architectural Engineering

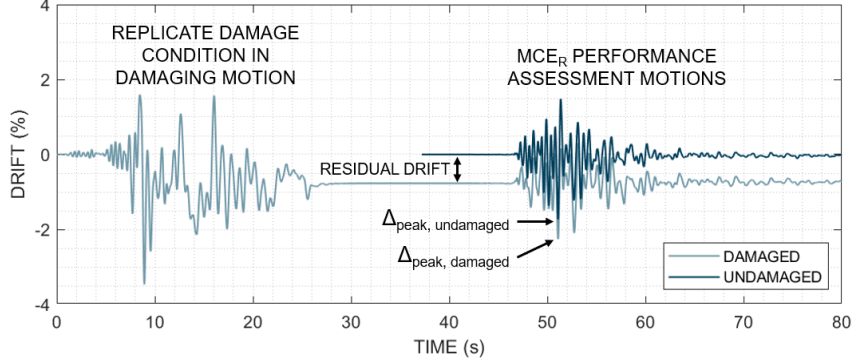
Figure 2.4: Story drift time history of analyses for one damage condition and one MCE_R -level performance assessment motion.

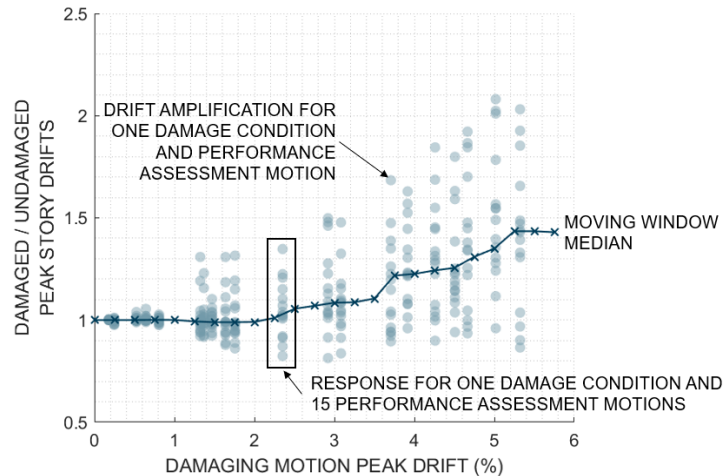
Figure 2.5: Median drift amplification ratios over a moving window for one building model subjected to 50 damage conditions and 15 MCE_R-level motions.

I plotted the drift amplification ratio against the peak story drift in the damaging motion. The results for one case are shown in Figure 2.5. I also calculated the moving median value to capture the trend in drift amplifications as damage (quantified as peak story drift) increases. I took the median value for all drift amplifications within each 1% drift bin at increments of 0.25% drift (*i.e.*, 0 - 1% drift, 0.25 - 1.25% drift, etc.). In each bin, I computed the 10th and 90th percentile to quantify the dispersion of drift amplifications.

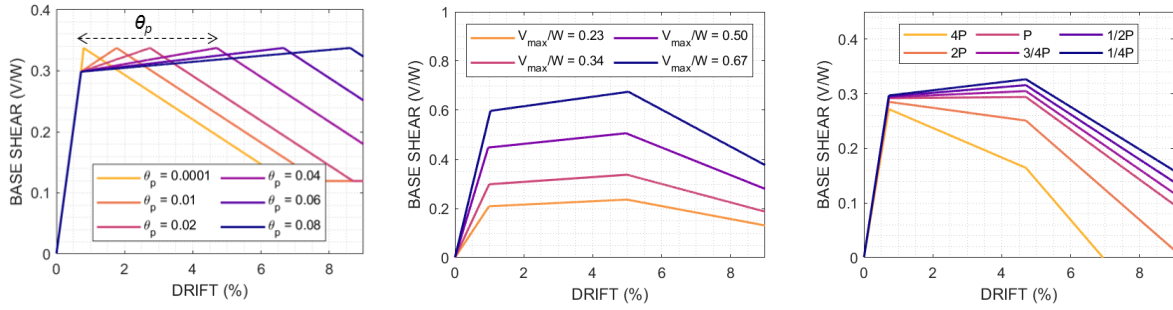
Figure 2.6: Static pushover response of SDOF models with (a) varied deformation capacity (θ_p) and constant strength and stiffness, and (b) varied strength and stiffness with constant yield and capping drifts, and (c) $P - \Delta$ effects.

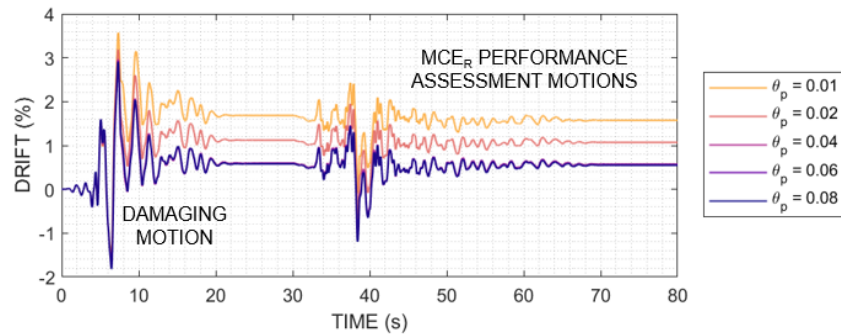
Figure 2.7: Drift histories of SDOF models with varied deformation capacities (θ_p) subjected to a back-to-back ground motion.

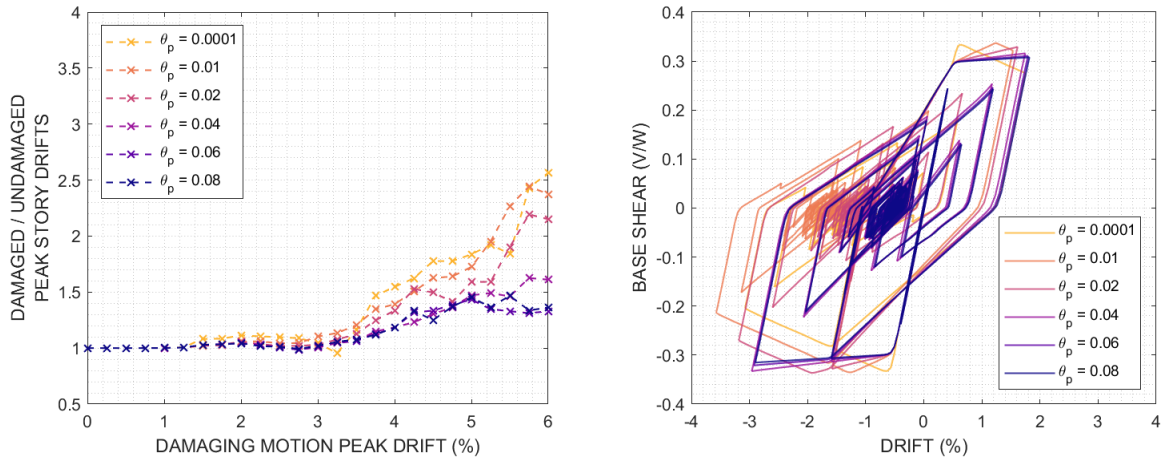
Figure 2.8: SDOF models with variation in deformation capacity (defined as θ_p) showing (a) moving window medians, and (b) hysteretic response during one damage condition and performance assessment.

First, I analyzed how deformation capacity affects future seismic performance and reparability in Figure 2.8a. For relatively small damaging motion drifts, *i.e.* relatively less damage, the ratio of drifts in the damaged and undamaged SDOF models is 1, indicating performance has not been impaired. Figure 2.8a shows, however, the steeper increase in drift amplifications in structures with

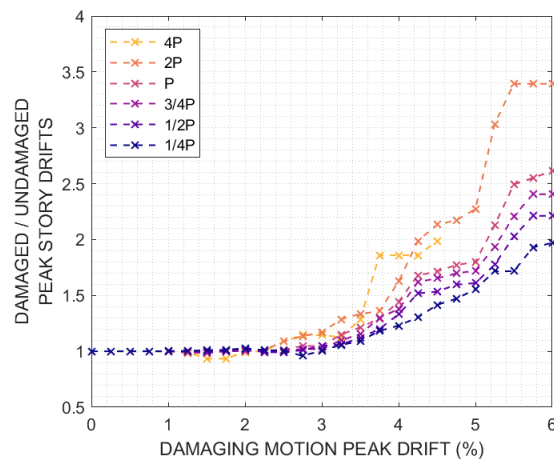
Figure 2.9: SDOF models with variation in $P - \Delta$ showing (a) moving window medians, and (b) hysteretic response during one damage condition and performance assessment.

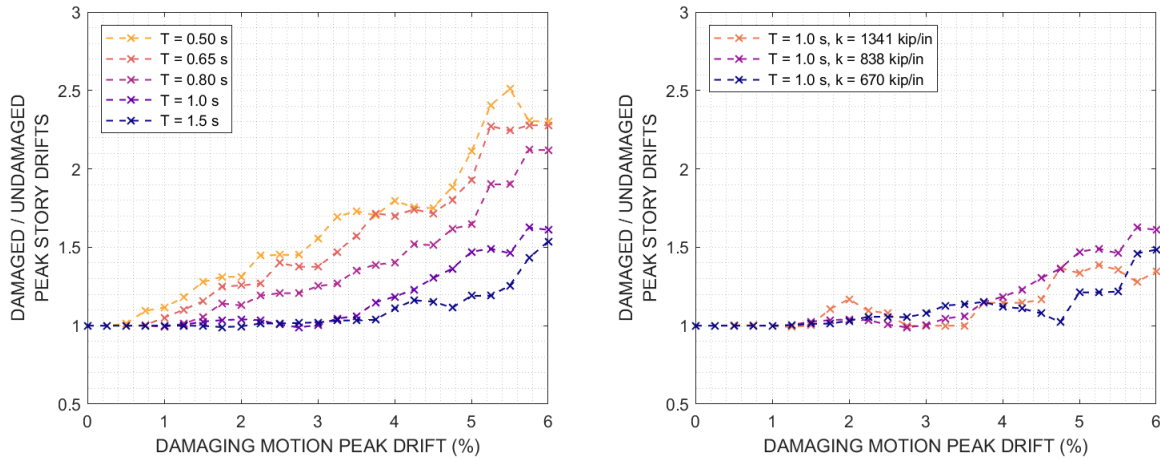
Figure 2.10: Median drift amplifications for SDOF models with variation in (a) stiffness and period, and (b) stiffness only.

Figure 2.10 shows the effect of stiffness, k , and first mode period, T , on drift amplifications. Stiffness alone (Figure 2.10b) does not strongly influence response, in terms of when damage impairs performance. However, period matters (Figure 2.10a) with shorter period structures seeing higher drift amplifications at lower levels of damage (drift). This trend is pronounced for $T < 1.0s$, where

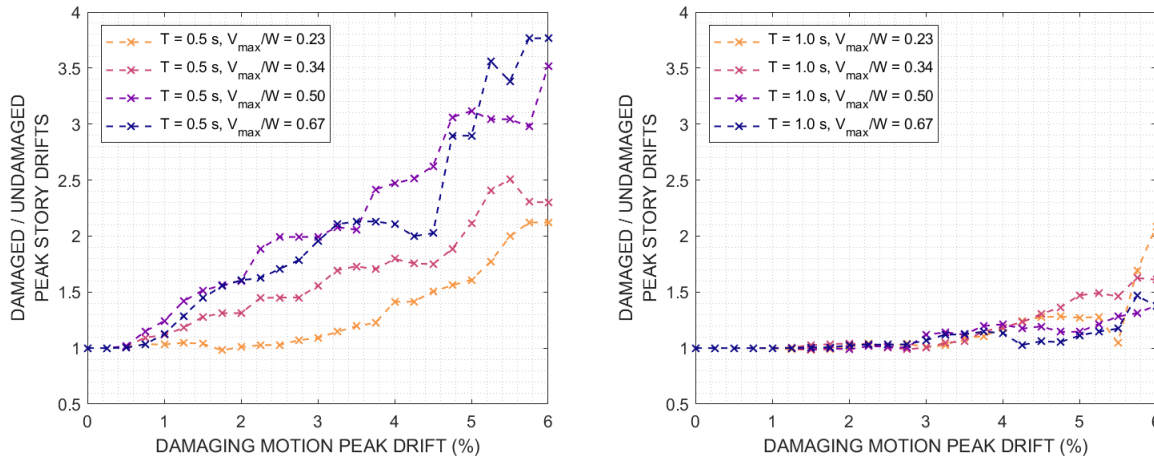
Figure 2.11: Median drift amplifications for SDOF models with variation strength and a first mode period (a) $T = 0.5$ s, and (b) $T = 1.0$ s.

Structure strength does not significantly affect a building’s capacity to withstand damage, particularly in longer period structures ($T > 1.0s$), as illustrated by Figure 2.11. In the short period case, drifts in the undamaged oscillators were strongly inversely correlated with strength and the drift amplification ratios were controlled by the small denominator in Equation 2.1. Stronger buildings had smaller drifts in the undamaged case, which is consistent with the equal displacement

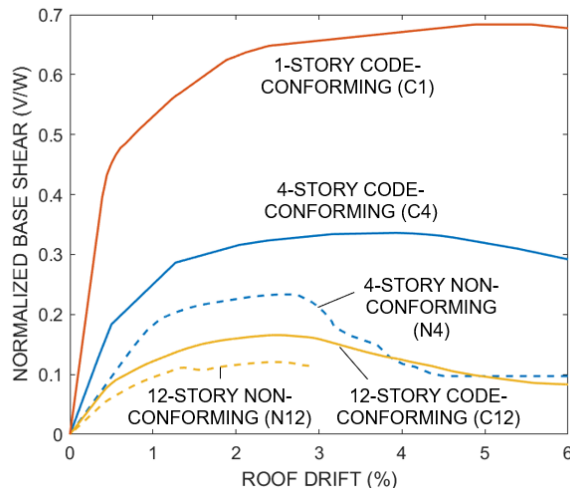
Figure 2.13: Response of RC frame buildings under static pushover loading. Base shear is normalized by building weight.

I used eigenvalue analysis to determine the building periods, and static pushover analysis to quantify building strength and deformation capacity to summarize building characteristics in Table 2.2. The static pushover responses of the buildings under inverted triangular loading used in this study are shown in Figure 2.13. These results indicate that the strength of the buildings and range of periods are typical of RC frame structures, and shows variation among the buildings.

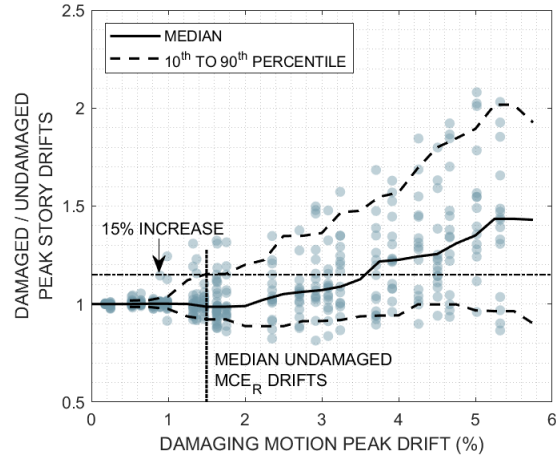
Figure 2.15: Reparability of 1-story code-conforming RC frame (Bldg C1) building, showing the change in response of in MCE_R -level motions, as a function of peak story drift in a damaging motion.

I also compared the performance of three code-conforming buildings with different heights and as a result, periods. These buildings include a 1-story structure (Bldg C1) with an initial period of 0.4 s, a 4-story structure (Bldg C4) with an initial period of 1.0 s, and a 12-story structure (Bldg C12) with an initial period of 2.4 s. Figure 2.15 shows the responses of the 1-story building, Figure 2.14a shows the 4-story response, and Figure 2.16 shows the 12-story response. The 1-story structure sees drift amplifications earlier than the 4- and 12-story counterparts, consistent with results of short-period SDOF structures. The repair trigger (*i.e.*, level of damaging motion drift at which the 90th percentile exceeds a 15% increase in demands) is 1.5% in the one-story building,

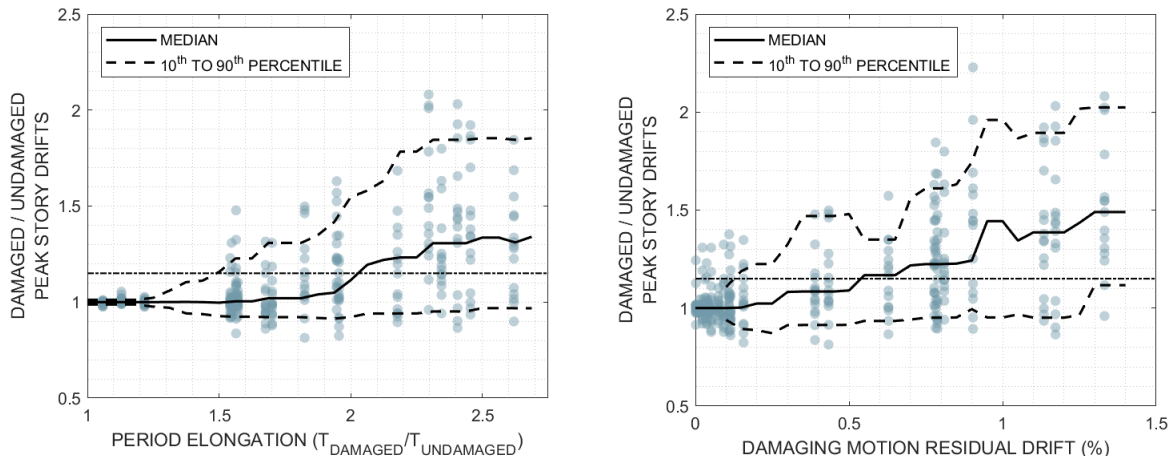
Figure 2.17: Relationship between drift amplifications and (a) period elongation and (b) residual drift in a 1-story, code-conforming building.

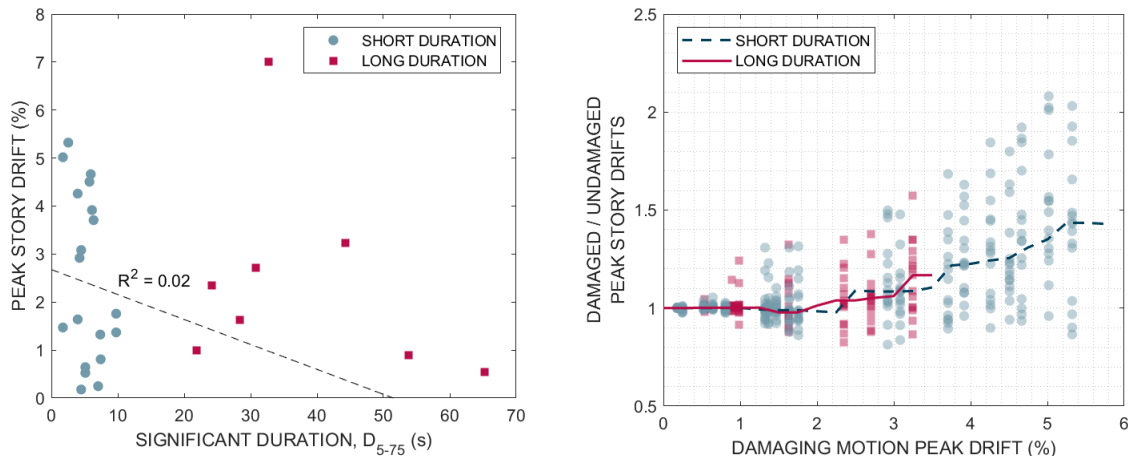
Figure 2.18: (a) Relationship between the the duration of the damaging motion and associated peak drift for selected damage conditions in a 1-story, code-conforming structure (Bldg C1). (b) Reparability of Bldg C1 for long and short duration ground motions.

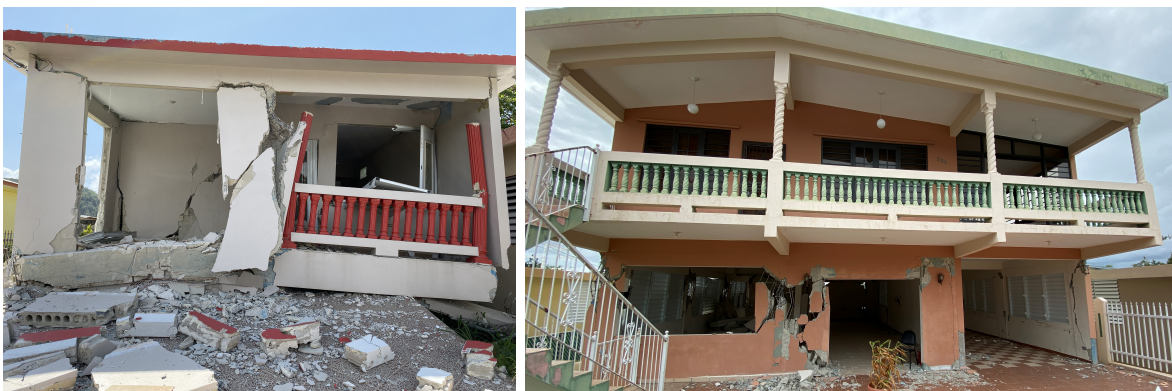
Figure 3.2: Damage to RC houses in Guánica with (a) an open ground story, showing loss of the first open story, and (b) masonry walls between columns at the first story, showing shear cracking in walls and columns. [Photos: Polly B. Murray]

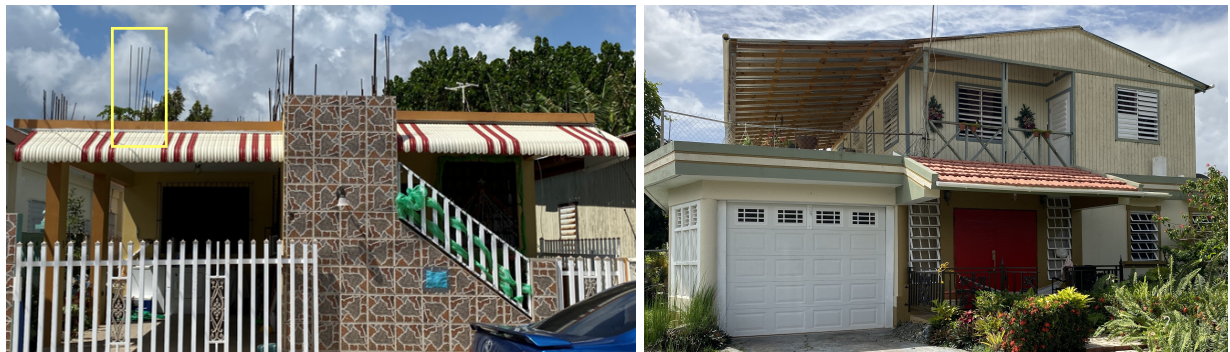
Figure 3.3: (a) Puerto Rican home with exposed reinforcing bars to facilitate house expansion. (b) Home with RC first story and wood frame second story (Yabucoa, Puerto Rico)[Photos: Polly B. Murray]

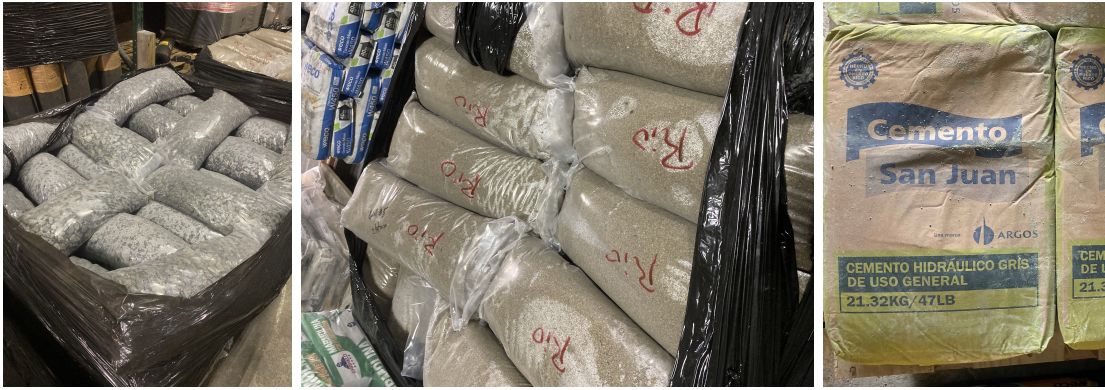
Figure 3.4: Commonly available concrete materials, including coarse and fine aggregate and cement, at a hardware store in San Juan, Puerto Rico. [Photos: Polly B. Murray]

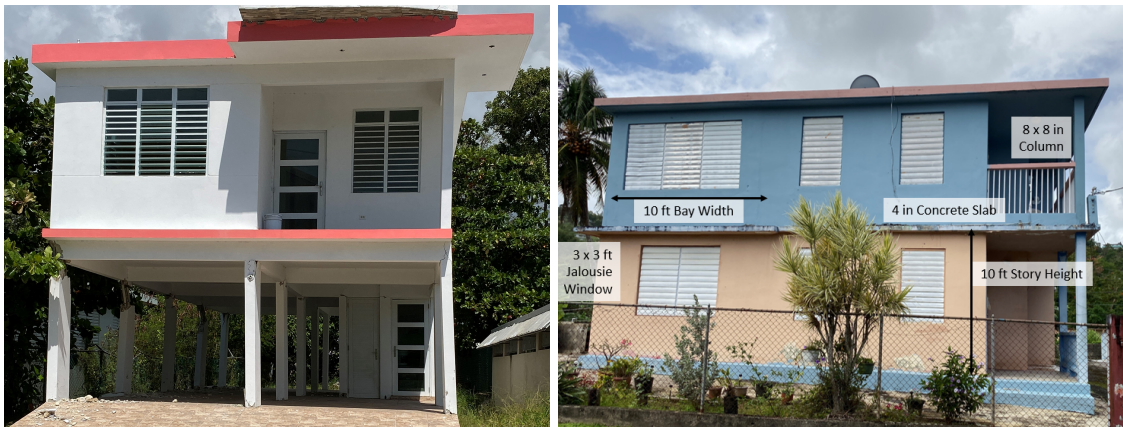
Figure 3.5: Typical RC houses in Guánica and Humacao, Puerto Rico. [Photos: Polly B. Murray]

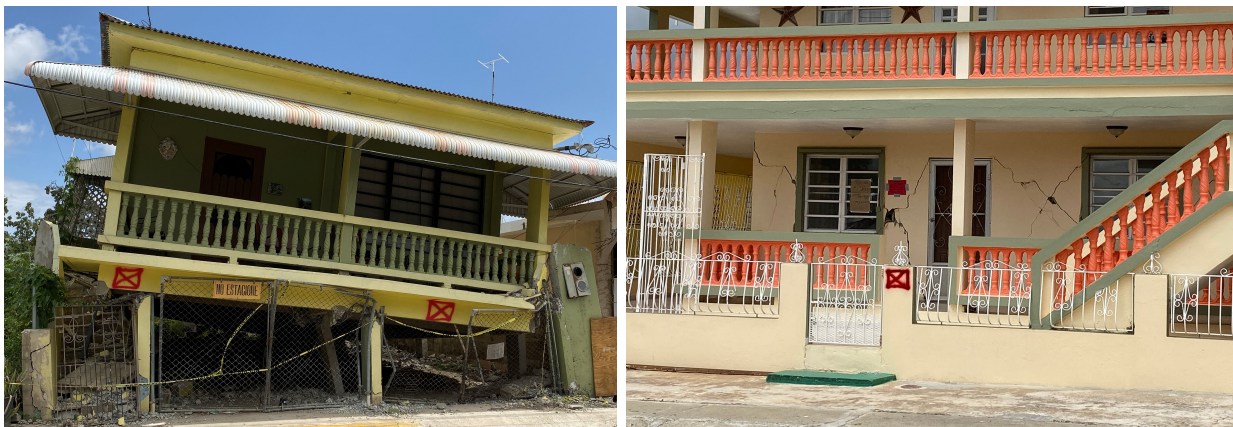
Figure 3.7: Houses in Guánica that were damaged during the January 7, 2020 earthquake. (a) failure in first story columns, (b) shear cracks in masonry walls. [Photos: Polly B. Murray]

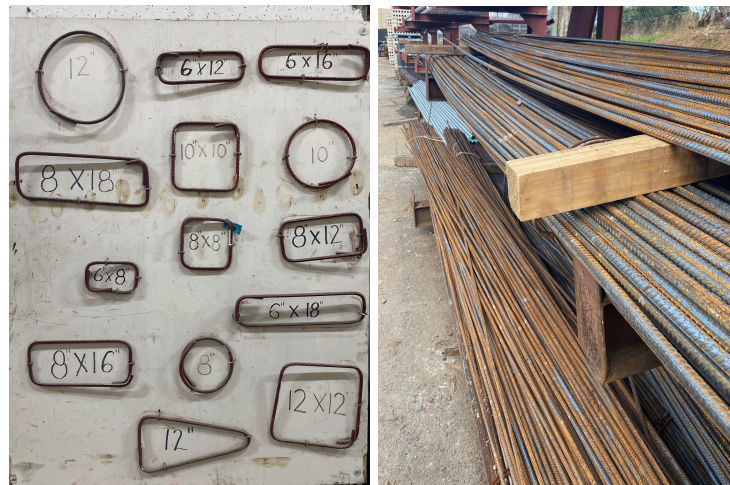
Figure 3.11: Steel reinforcing bars used in home construction. Transverse ties are sold in pre-defined bent shapes; the 6 x 12 in bars are most common. The most common longitudinal bars are no. 4 and no. 5, and are often stored outside (Humacao, Puerto Rico). [Photos: Polly B. Murray]

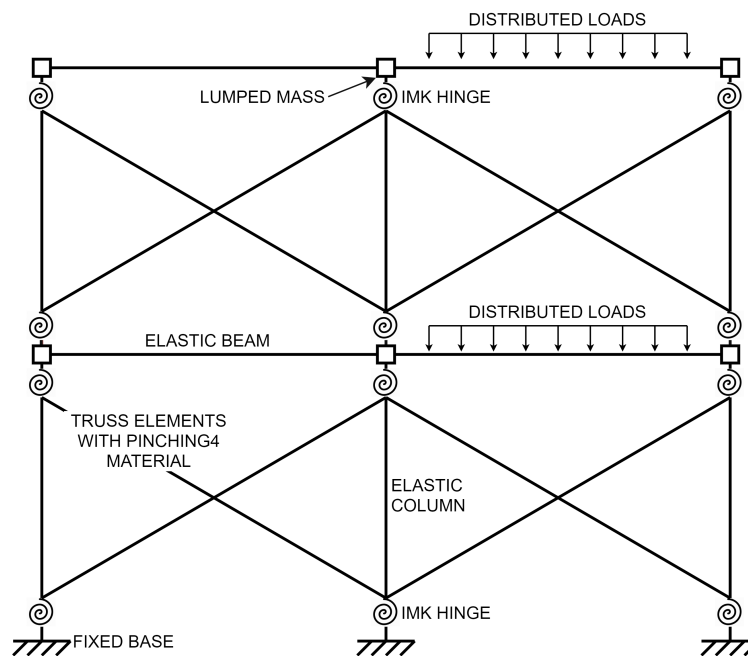
Figure 3.13: Diagram of models of a two-story, two-bay house with infilled or confined masonry walls.

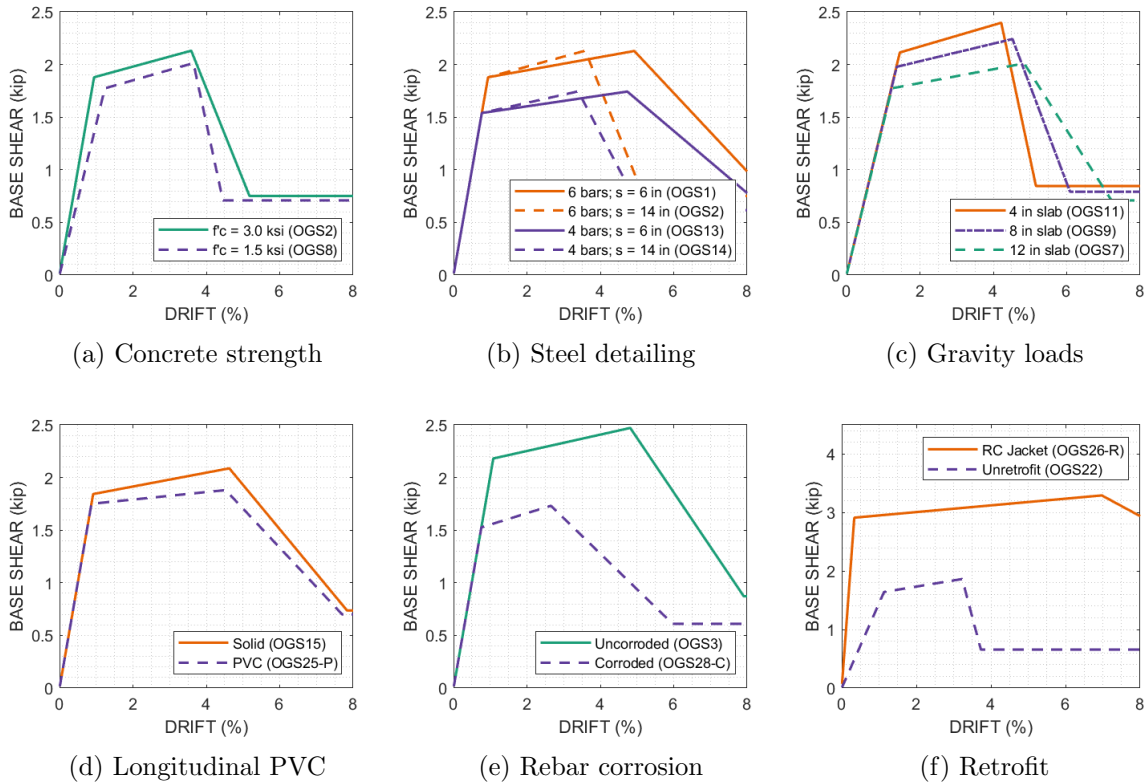
Figure 3.15: Static pushover response of columns configurations.

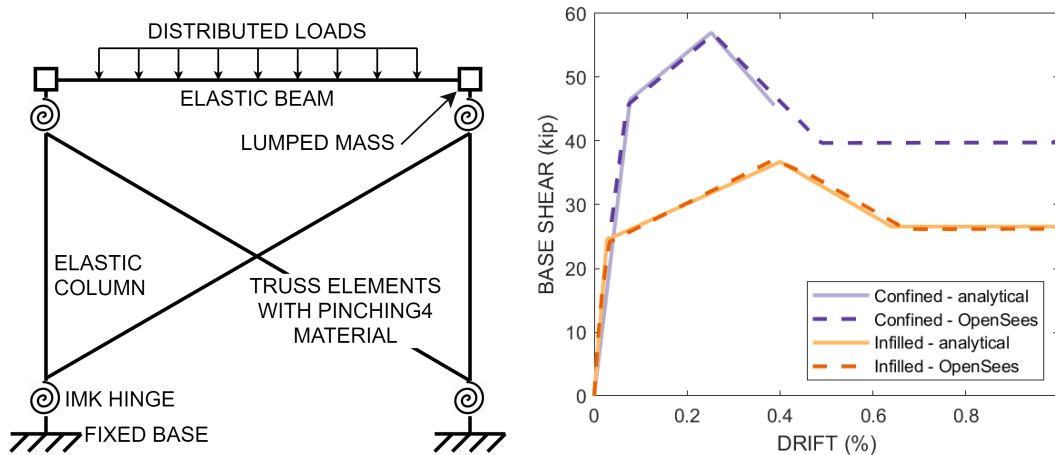
Figure 3.16: (a) Diagram of the model of a single bay with RC columns and a concrete masonry panel, illustrating the adopted modeling approach; and (b) analytical backbone and static pushover response of one bay calibrated for infilled and confined construction.

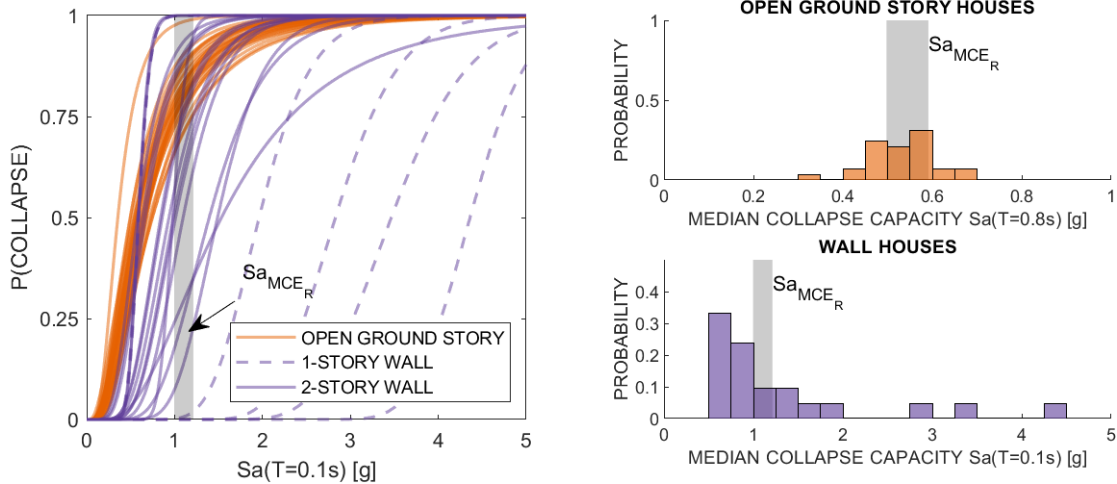
Figure 3.18: (a) Summary of collapse fragilities for all archetype houses; (b) distribution of median collapse capacities for informally-constructed RC open-ground-story houses and houses with masonry walls.

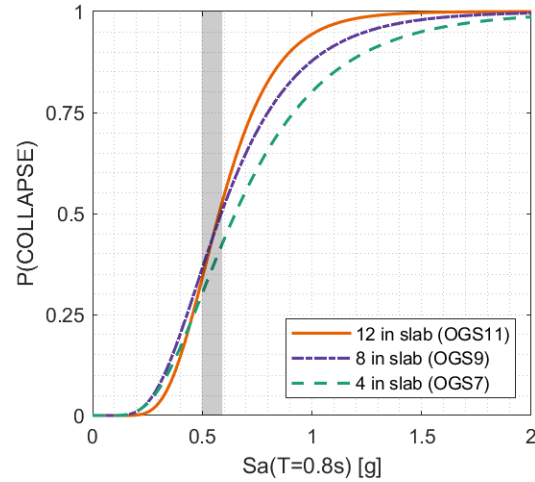
Figure 3.19: Collapse fragilities of open-ground-story houses with variation in weight, induced by floor and roof slab thicknesses listed in the legend.

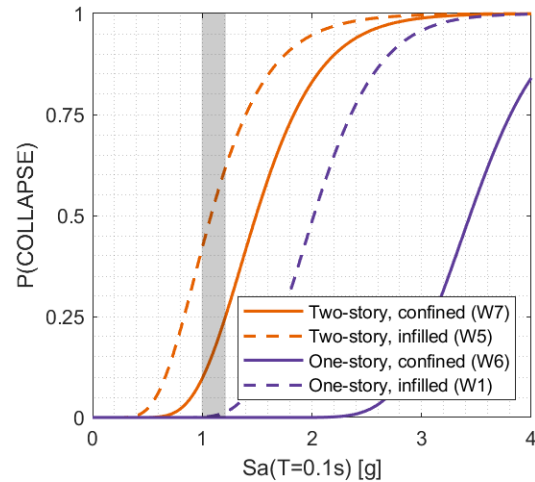
Figure 3.23: Collapse fragilities for one- and two-story houses with infilled and confined masonry walls, showing the large benefit from the confined construction technique.

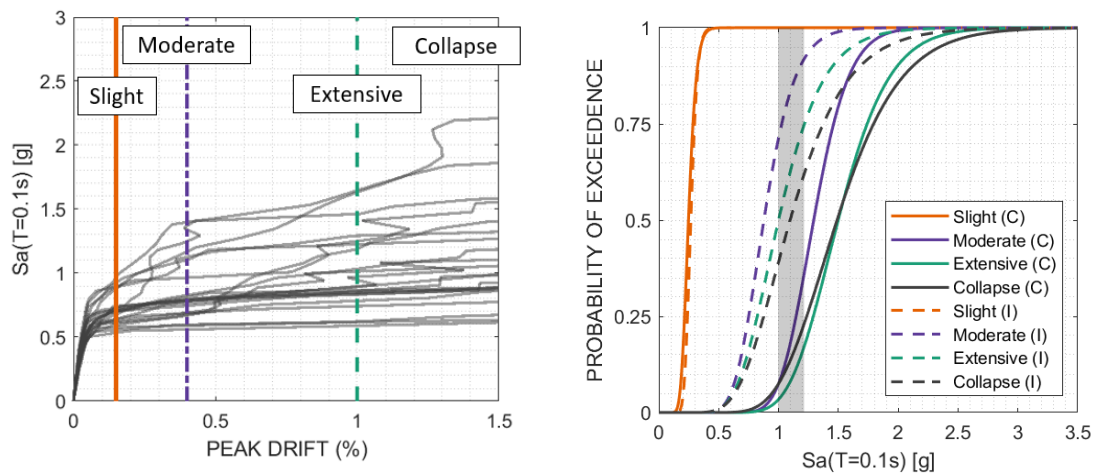
Figure 3.24: (a) Damage states, defined by the level of peak story drift. (b) Probability of exceedance for slight, moderate, extensive, and collapsed damage states in a two-story house with infilled (I) and confined (C) masonry walls.

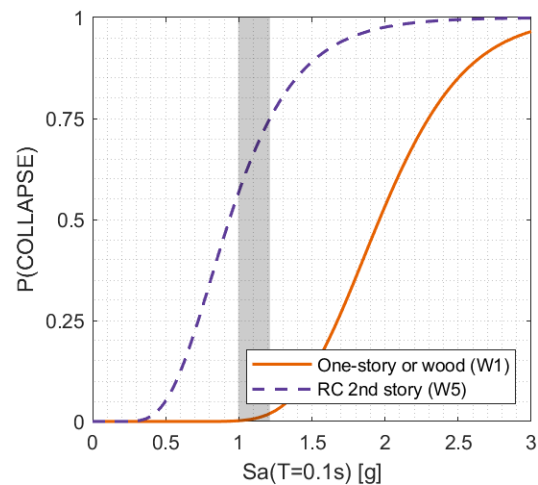
Figure 3.27: Collapse fragilities for one- and two-story houses. The addition of an RC second story drastically increases collapse risk, while a wood frame second story, which does not increase building weight significantly, does not.

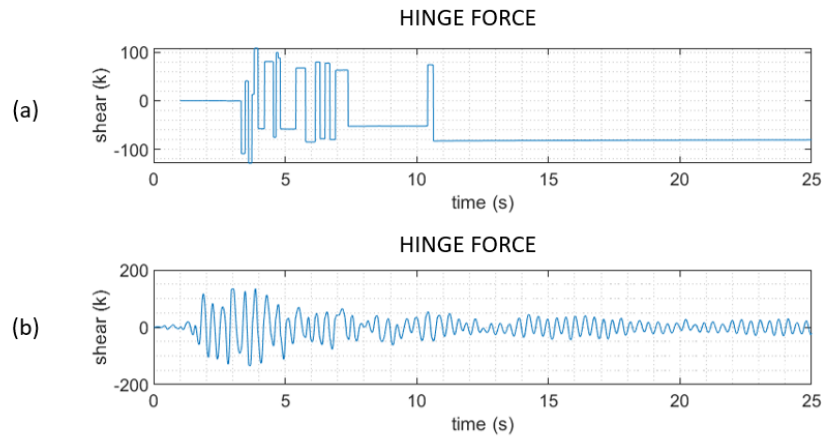
Figure B.1: Hinge response history (a) before and (b) after error generating discontinuity in the hinge was addressed
