CONTRIBUTIONS TO MESA VERDE ARCHAEOLOGY: IV
SITE 1086, AN ISOLATED, ABOVE GROUND KIVA IN
MESA VERDE NATIONAL PARK, COLORADO

ROBERT H. LISTER

BOULDER, COLORADO, FEBRUARY, 1967

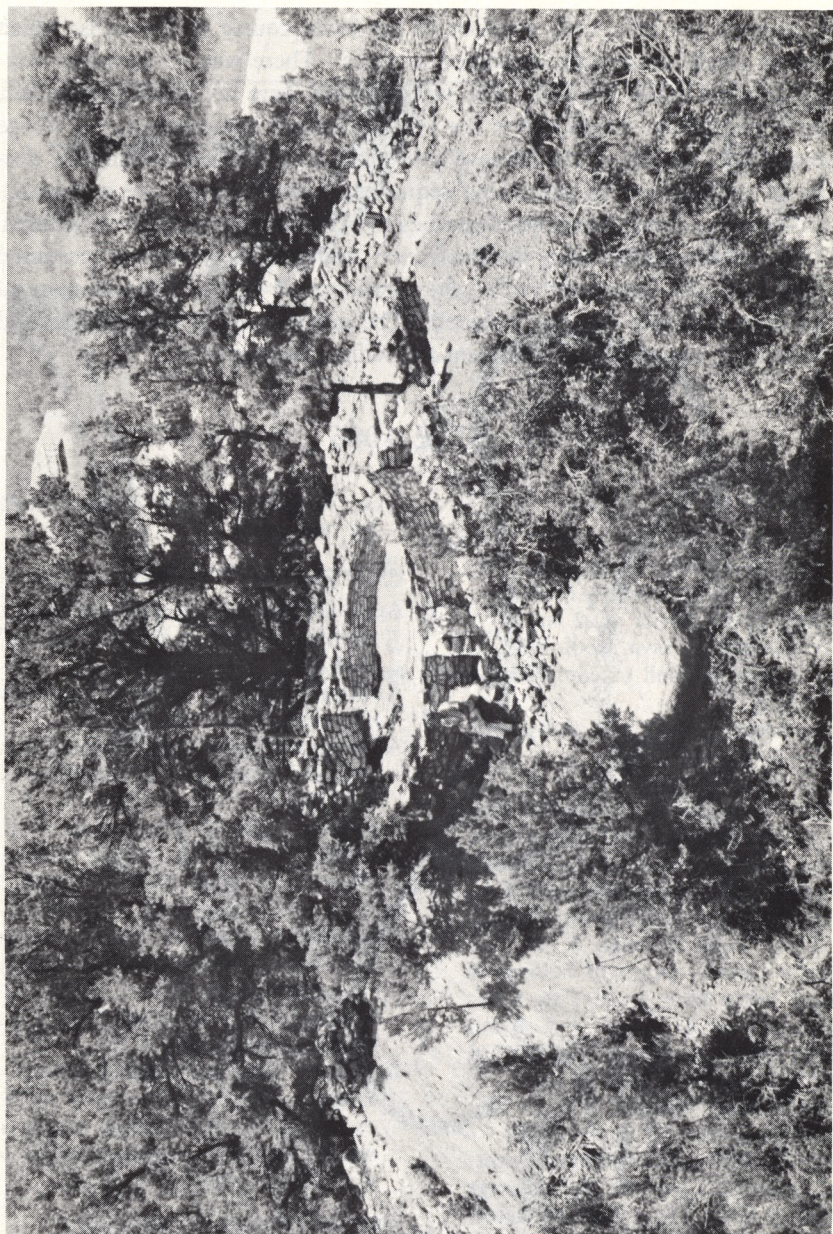
PLATE 1. Hilltop and kiva, during excavation, looking southwest.

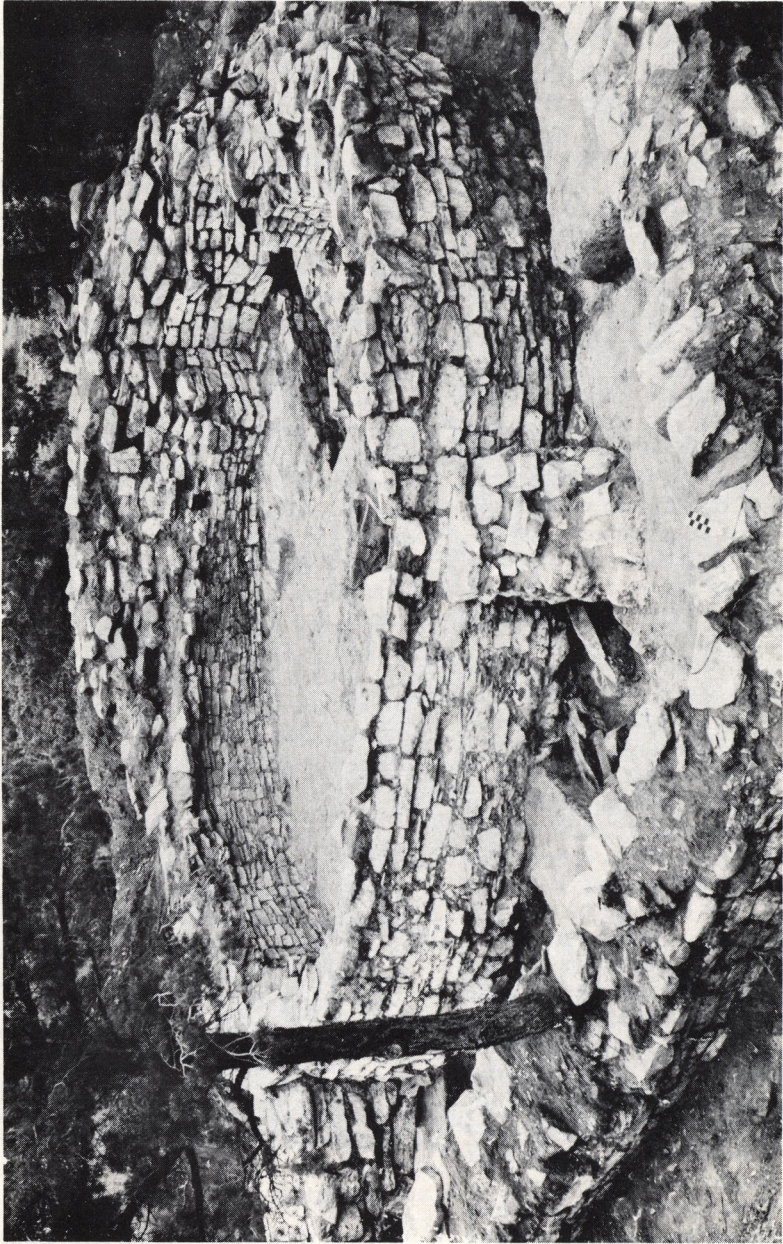
PLATE 2. Kiva, after excavation, looking southeast. Note the following features: thick retaining wall in foreground; Buttrass 2 in center of view; Buttrass 3 on left; the firepit, subfloor ventilator tunnel, and southern recess within the kiva; and buttrasses 1 and 4 on the exterior of the far wall on either side of the recess.

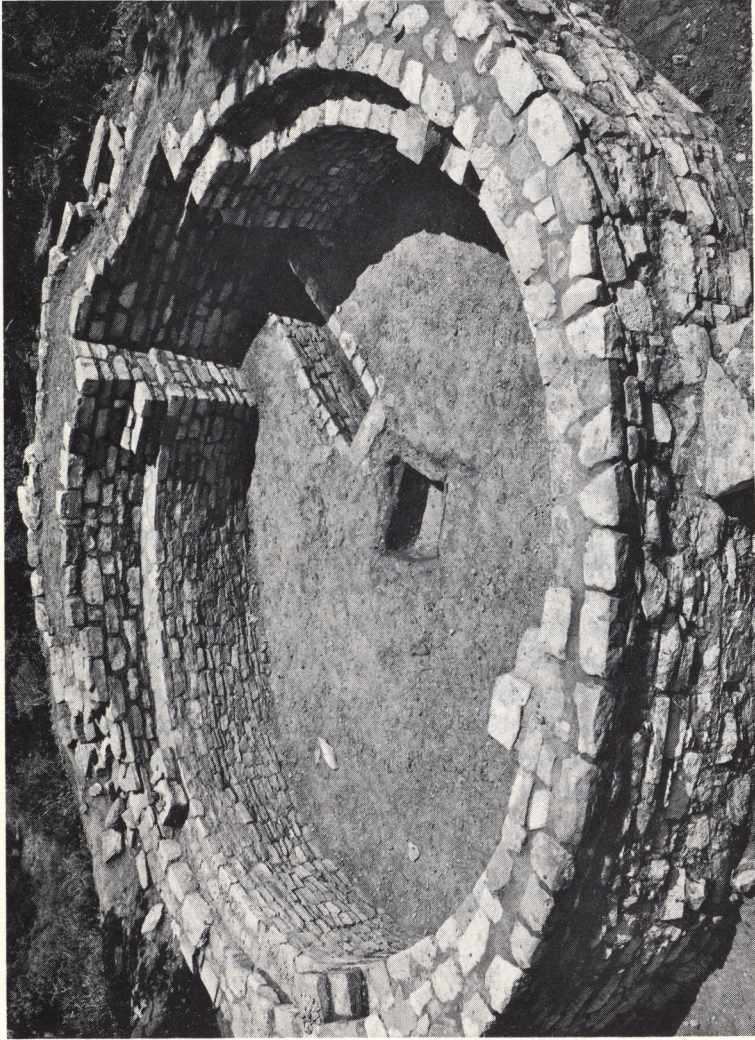
PLATE 3. Kiva, after stabilization, looking southeast. Note Buttress 2 in foreground, kiva wall, banquette, pilasters, fireplace, ventilator, southern recess, and buttresses 1 and 4. The pilasters on either side of the recess have been reconstructed the same width as the others; actually they were only one stone wide upon excavation. (Photo courtesy National Park Service.)

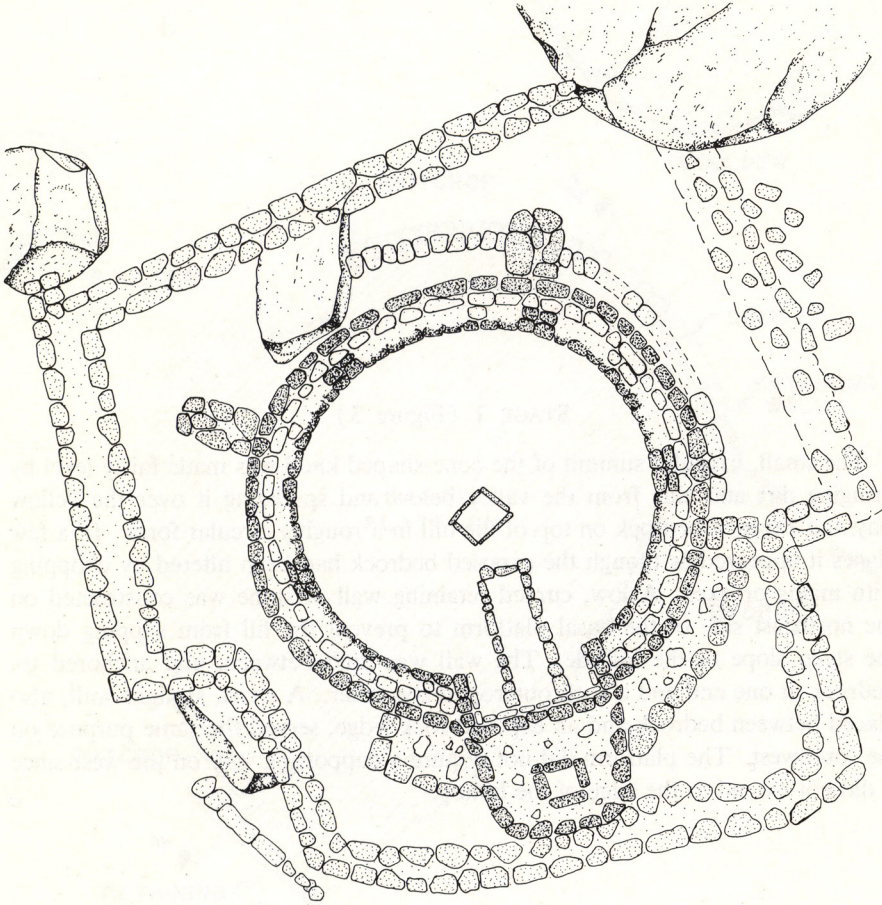
FIGURE 2. Plan, Site 1086.

The accompanying Figure 2 is a plan of the kiva and all of its external features exposed by our excavations. To better understand the order of events which led to this ultimate form, the following stages, or conditions extant at a given point in the history of the kiva, are presented.

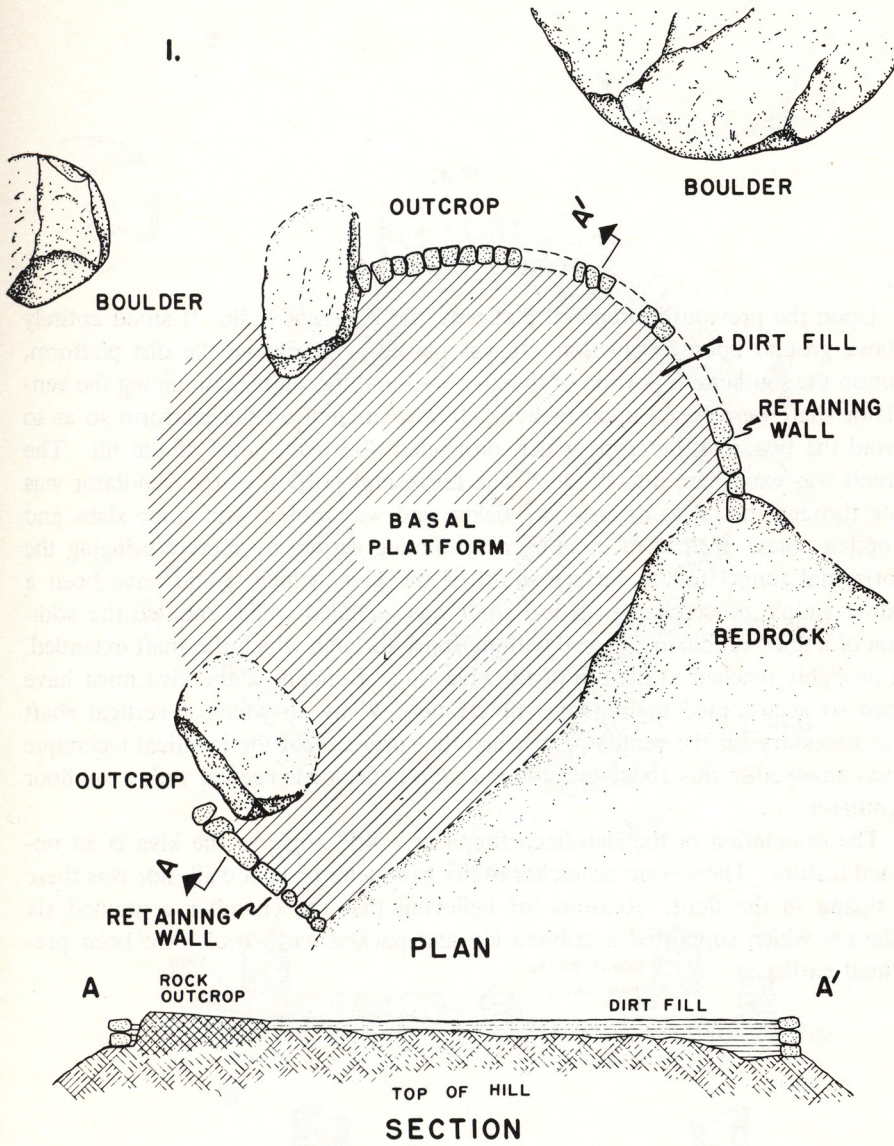
FIGURE 3. First Stage of Kiva.

The small, irregular summit of the cone-shaped knoll was made fairly level by bringing dirt and clay from the valley below and spreading it over the yellow clay and exposed bedrock on top of the hill in a roughly circular form. In a few places it appeared as though the exposed bedrock had been altered by chopping with mauls or axes. A low, curved retaining wall of stone was constructed on the northeast side of the basal platform to prevent the fill from slipping down the steep slope of the hillside. The wall was built between, and anchored to, bedrock at one end and a rock outcrop at the other. A short, straight wall, also placed between bedrock and an exposed rock ledge, served the same purpose on the southwest. The platform did not require a supporting wall on the west since it did not extend to the edge of the hilltop.

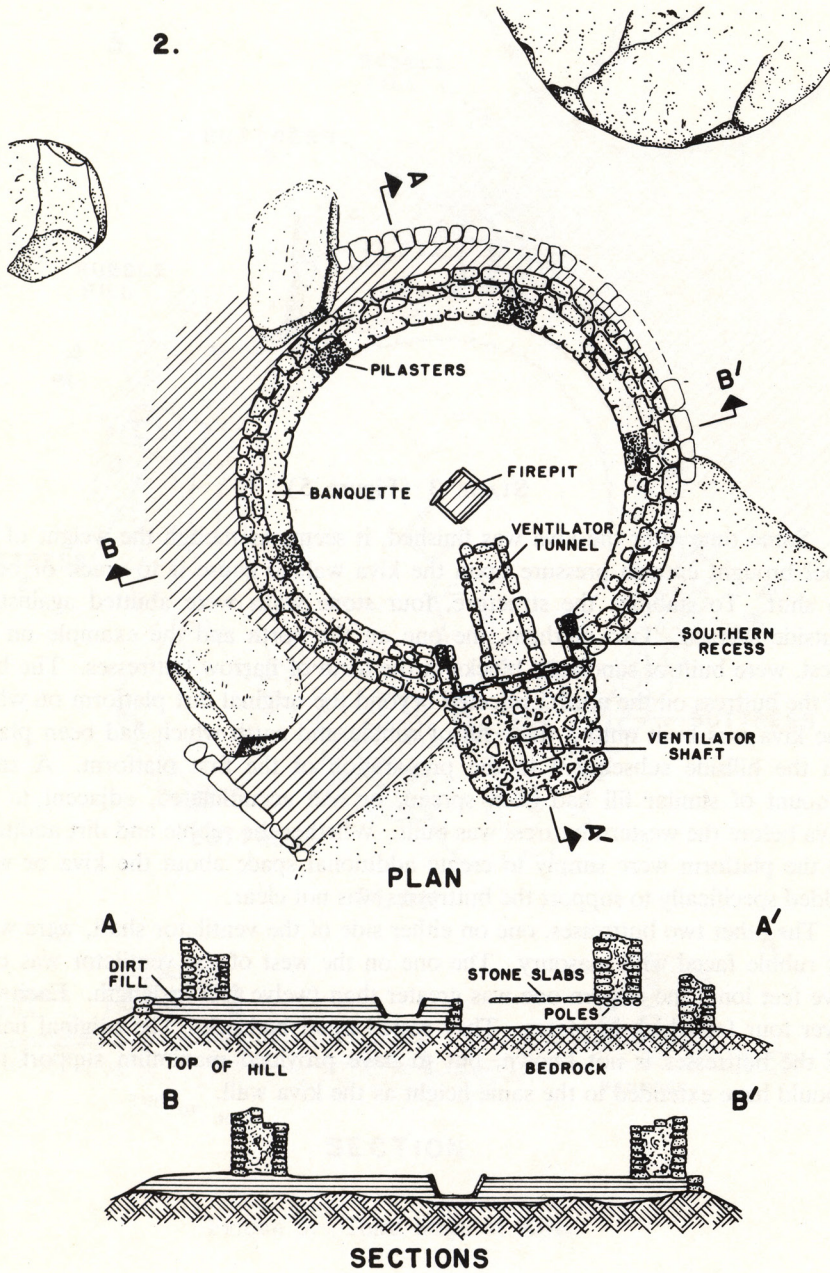
FIGURE 4. Second Stage of Kiva.

Upon the previously prepared platform, the kiva was built. It stood entirely above ground upon completion. It was placed primarily on the dirt platform, but on the southeast a portion of the kiva wall and the rubble containing the ventilator shaft were based upon bedrock. It was situated on the platform so as to avoid the two rock outcrops which protruded above the level of the fill. The firepit was excavated into the fill. The horizontal portion of the ventilator was dug through the fill to the bedrock below and was roofed with stone slabs and wooden poles. Instead of creating a ventilating system by merely bringing the horizontal tunnel to the surface south of the kiva, which would have been a rather simple procedure, a vertical shaft was included which entailed the addition of a thick rubble mass faced with masonry through which the shaft extended. It probably reached to the top of the kiva wall. Builders of the kiva must have been so accustomed to building subterranean kivas, in which a vertical shaft was necessary for the ventilator to reach the surface, that the identical technique was employed in this above ground unit. No deflector is needed with a subfloor ventilator.

The orientation of the slab-lined firepit at a 45° angle to the kiva is an unusual feature. There were no niches in the banquette or kiva wall, nor was there a sipapu in the floor. Reasons for believing that the chamber contained six pilasters which supported a cribbed log and packed earth roof have been presented earlier.

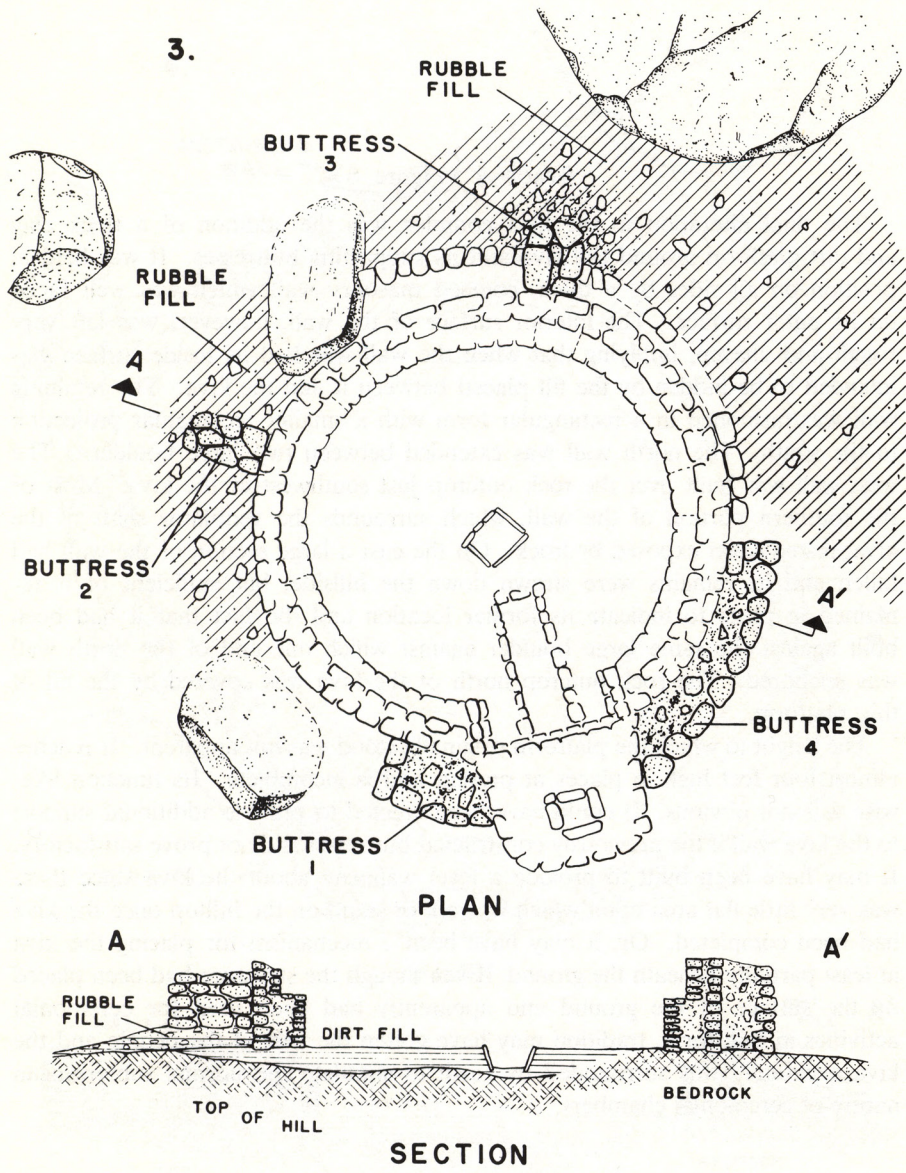
FIGURE 5. Third Stage of Kiva.

Some time after the kiva was finished, it seems as though the weight of the roof brought enough pressure upon the kiva wall to cause it to crack or begin to shift. To stabilize the structure, four stone walls were abutted against its outside surface. Two of them, the one on the north and the example on the west, were built of sandstone blocks in the form of narrow buttresses. The base of the buttress on the north projected beyond the original dirt platform on which the kiva was built onto a thick fill of rubble and earth which had been placed on the hillside subsequent to the preparation of the first platform. A small amount of similar fill had been spread, or had accumulated, adjacent to the kiva before the western buttress was built. Whether the rubble and dirt additions to the platform were simply to create additional space about the kiva or were added specifically to support the buttresses was not clear.

The other two buttresses, one on either side of the ventilator shaft, were walls of rubble faced with masonry. The one on the west of the ventilator was over five feet long; the eastern one was greater than twelve feet in length. Each was over four feet thick in places. They rested upon bedrock. The original height of the buttresses is not known, but to have provided maximum support they should have extended to the same height as the kiva wall.

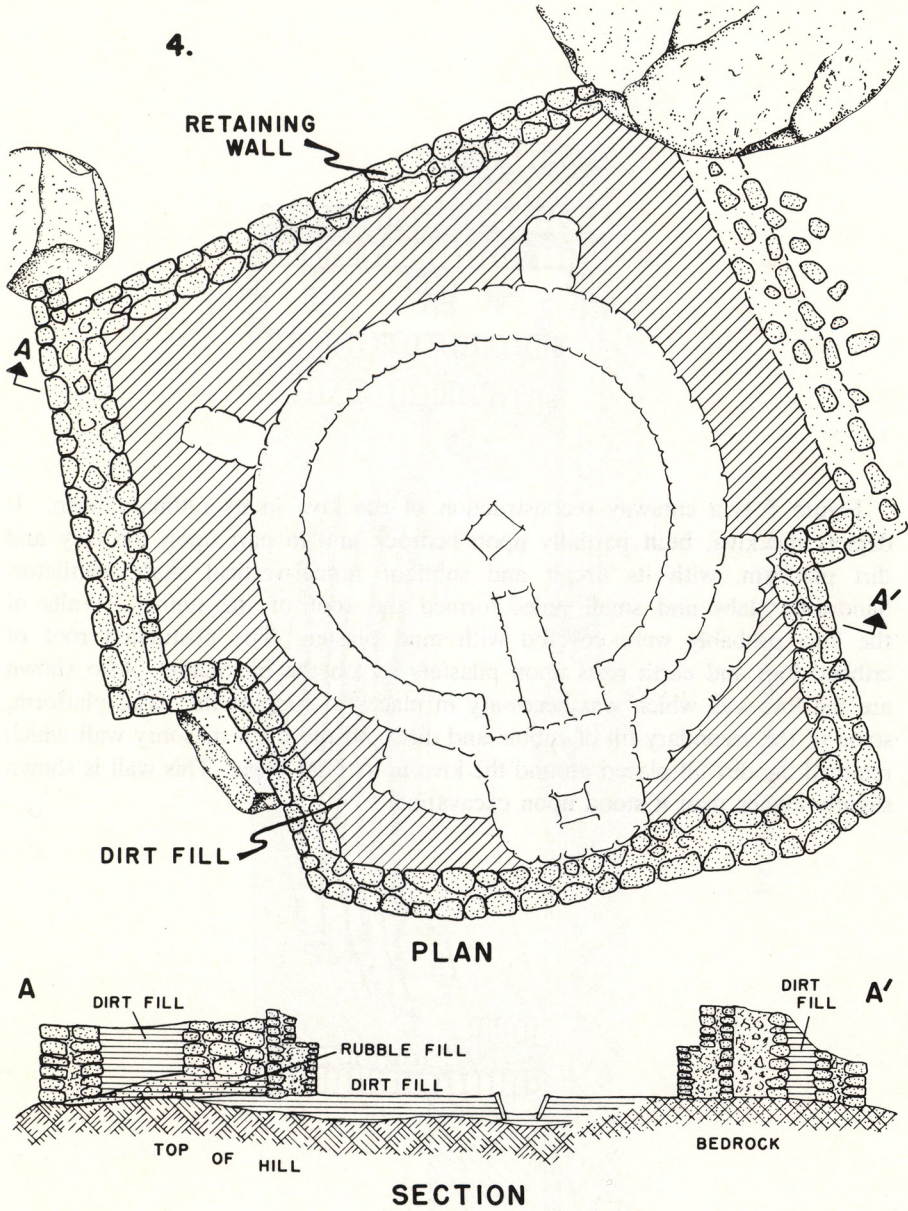
FIGURE 6. Fourth Stage of Kiva.

The final alteration to the kiva complex was the addition of a thick clay and dirt platform around the kiva and its supporting buttresses. It was held in position on all sides by a thick, coursed masonry wall which was well faced on its outer surface. The interior surface of the wall, however, was left very rough and uneven, implying that when the wall was laid its inside surface was intended to be hidden by the fill placed between it and the kiva. The retaining wall was fashioned in a rectangular form with a smaller rectangular projection to the south. The north wall was extended between two large boulders. The west wall was built over the rock outcrop just southwest of the kiva. Most of the southern portion of the wall, which surrounds the ventilator shaft of the kiva, rested upon exposed bedrock. On the east a large section of the wall had fallen and its remains were strewn down the hillside, but sufficient of it remained in place to indicate its former location and the fact that it had been built against the same large boulder against which one end of the north wall was anchored. The rock outcrop north of the kiva was covered by the fill of this platform.

The height to which the platform originally stood was not apparent. It reaches almost four feet high in places at present and is incomplete. Its function likewise was not obvious. It could have been erected to provide additional support to the kiva wall if the previously constructed buttresses did not prove satisfactory. It may have been built to provide a level walkway about the kiva since there was very little flat area upon which to walk or stand on the hilltop once the kiva had been completed. Or, it may have been a mechanism for placing the kiva at least partially beneath the ground. Even though the structure had been placed on the surface of the ground and apparently had been used for ceremonial activities in that form, tradition may have gotten the best of the people and the kiva eventually was surrounded by earth to simulate the normal subterranean nature of ceremonial chambers.

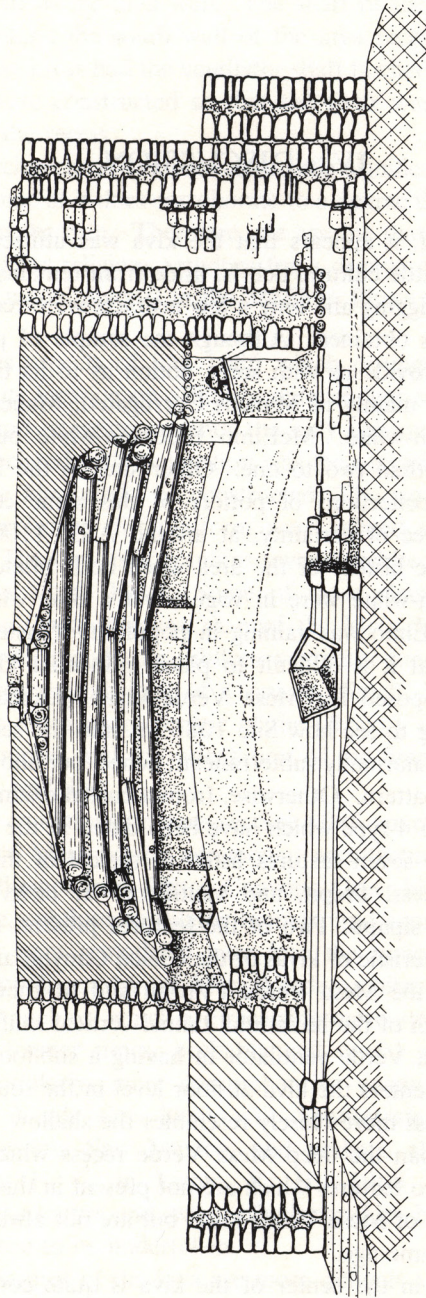
FIGURE 7. Reconstruction of Kiva.

Figure 7 is a cutaway reconstruction of the kiva in its ultimate form. It depicts the kiva, built partially upon bedrock and in part upon the clay and dirt platform, with its firepit and subfloor tunnel-vertical shaft ventilator. Sandstone slabs and small poles formed the roof of the tunnel. Walls of the kiva probably were covered with mud plaster. The postulated roof of cribbed logs and earth rests upon pilasters set on the banquette. Also shown are the low wall which was necessary in places to support the basal platform, some of the secondary fill of rubble and dirt, and the thick masonry wall which retained the dirt fill placed around the kiva in its final stage. This wall is shown slightly higher than it stood upon excavation.
