A new remote hazard and risk assessment framework for glacial lakes in the Nepal Himalaya

David R. Rounce¹, Daene C. McKinney¹, Jonathan M. Lala¹, Alton C. Byers², and C. Scott Watson³

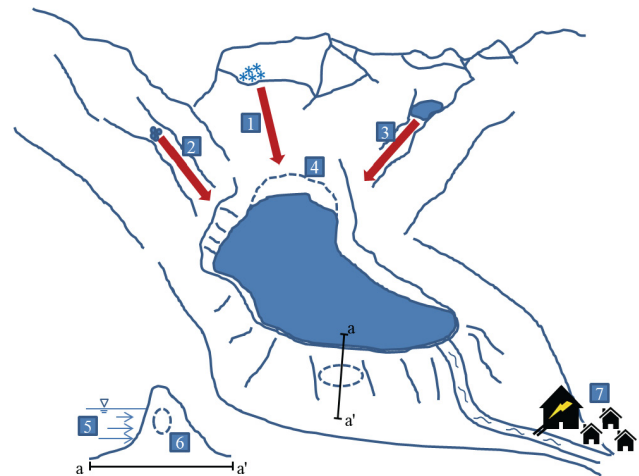
**Figure 2.** Schematic of GLOF hazard parameters used in the new method: (1) snow/ice avalanche, (2) rockfall, (3) flood from upstream lake, (4) lake expansion, (5) hydrostatic pressure, (6) ice-cored moraine, and (7) downstream impact.

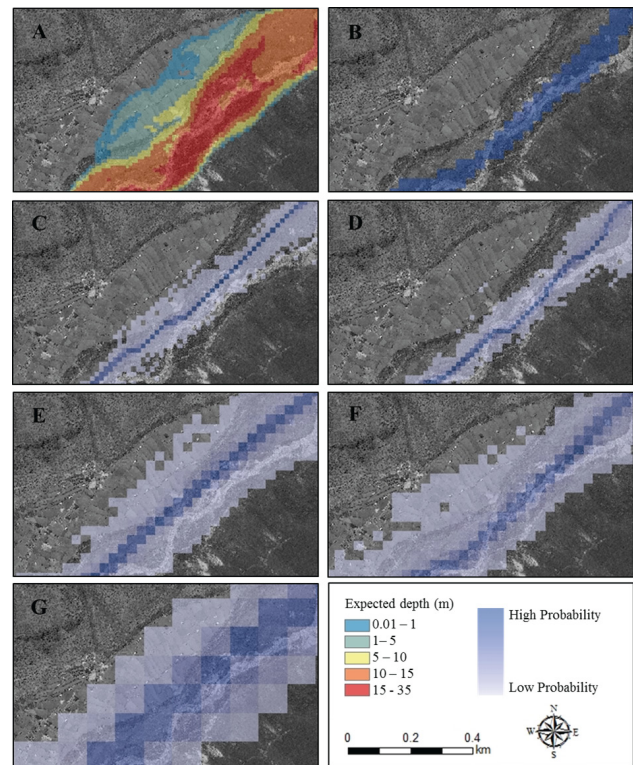
Figure 3. Inundated areas at Dingboche for a GLOF from Imja Tsho using (a) FLO2D (Somos-Valenzuela et al., 2015), (b) the MSF model using the GDEM, and (c–g) the MC-LCP model with various DEMs and pixel sizes: (c) SRTM 90 m resampled 15 m, (d) GDEM 30 m resampled 15 m, (e) SRTM 90 m resampled 30 m, (f) GDEM 30 m, and (g) SRTM 90 m.

The lack of data related to previous GLOFs makes it difficult to assess the performance of different models. Watson et al. (2015) used the 1985 GLOF at Dig Tsho to compare the performance of the MSF and MC-LCP models to the actual flood extents. These models used the GDEM resampled to 15 m and were found to perform reasonably well, although the MC-LCP model had a larger inundation area and fewer artefacts. Watson et al. (2015) also observed that in high relief Himalayan catchments, the requirements for an artificially filled DEM by the MSF model created large linear inundation artefacts, whereas the MC-LCP model displayed improved flow routing and hence is more appropriate for assessing first-order socio-economic impacts of a potential GLOF. It is important to note that the GDEM reflects the post-GLOF terrain, which was severely altered by the GLOF (Vuichard and Zimmermann, 1987). Ideally, a pre-GLOF DEM would be used for model validation so modeled flood extents would not be affected by scouring and deposition in the main channel. Furthermore, the comparison reveals multiple areas where the MC-LCP model does not capture the actual flood extent, which would be highly problematic for a hazard assessment if these areas were populated.

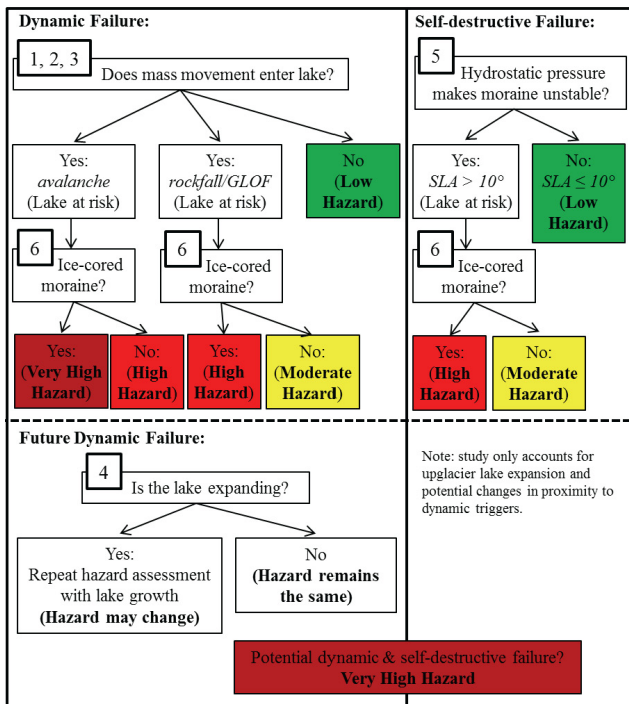
Figure 4. Hazard classification flow chart for determining the hazard associated with a glacial lake (numbers refer to hazard parameters in Fig. 2).

The hazard elements described above are crucial for determining whether a glacial lake is susceptible to a dynamic or self-destructive failure. Figure 4 shows the workflow that is used to determine whether the lake is susceptible to failure and how the cause of failure translates into the hazard associated with the lake. The most dangerous situation is a glacial lake that is susceptible to both dynamic and self-destructive failures, which would classify the lake as a very high hazard. Susceptibility is defined as a hazard greater than low; i.e., a lake that is considered a moderate hazard for dynamic failure and a moderate hazard for self-destructive failure is still classified as very high hazard. The other scenario that classifies a lake as very high is a lake with a buried ice core that is susceptible to a snow/ice avalanche, as the ice core may alter the height of the moraine over time and/or the erosion and breach of the moraine. A lake that is susceptible to avalanches but does not have an ice core is classified as a high hazard. Snow/ice avalanches were given the highest hazard classification since they are the most frequent cause of failure in the Himalaya (Emmer and Cochachin, 2013). Additionally, any lake with a buried ice core that is susceptible to a rockfall or upstream GLOF, or has a steep SLA, is classified as a high hazard. These hazard ratings are meant to reflect self-destructive failures being the second most common cause of GLOFs followed by mass movement entering

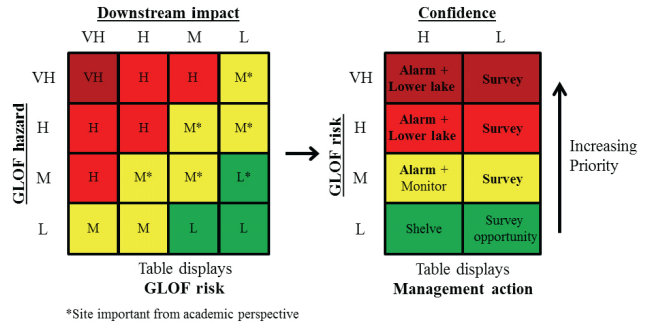
Figure 5. Risk management and action framework. Left table: GLOF risk is a function of the hazard and downstream impact. Right table: the recommended course of action for a given glacial lake based on the type of assessment.

The risk of a GLOF is a function of a glacial lake’s hazard and its potential downstream impact (Fig. 5). This study uses the same ranking scheme as Worni et al. (2013). Very high risk lakes are defined as any lake where the downstream impact is very high; i.e., lives and costly projects are threatened, and the hazard of the lake is very high. High risk is defined as a lake that has a high downstream impact and a high hazard, a very high hazard and high/moderate downstream impact, or vice versa. Moderate risk is defined as a lake that has a moderate hazard and moderate downstream impact, a moderate/low hazard and high downstream impact or vice versa, or a low hazard and very high downstream impact or vice versa. Lastly, low risk refers to the remaining scenarios that are less of a threat and is defined as lakes that have a low downstream impact and a low hazard, or a moderate hazard and low downstream impact or vice versa. It is important to note that any site that is at risk of a dynamic or self-destructive failure is valuable from an academic perspective as it may help improve the current state of knowledge of GLOF hazards.

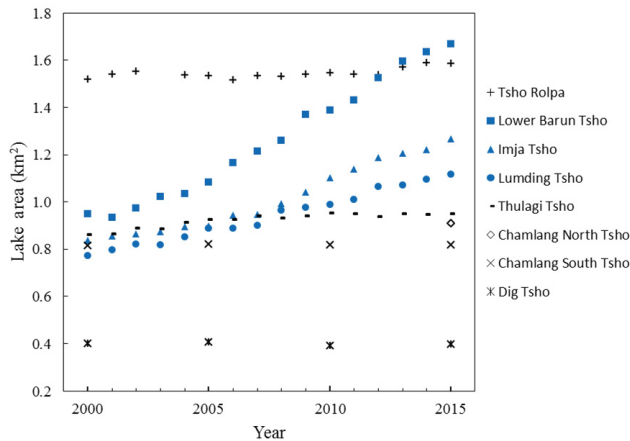
Figure 6. Area of glacial lakes derived from satellite imagery using the NDWI method from 2000 to 2015 (details in Table S.7).

Figure 6 shows that Lower Barun Tsho, Imja Tsho, and Lumding Tsho continue to expand rapidly, while Tsho Rolpa and Thulagi Tsho have stagnated in recent years. The other lakes (Chamlang North Tsho, Chamlang South Tsho, and Dig Tsho) have already detached from their glaciers and lack the ability to expand. These expansion estimates combined with the mass movement trajectories reveal that Imja Tsho is susceptible to a dynamic failure in the next 10–20 years (Table 5). These results have important implications for the hazard and risk associated with Imja Tsho as they indicate that in 10–20 years Imja Tsho may be a very high hazard and high risk (Table 6). Additionally, the expansion of Lower Barun Tsho and Lumding Tsho makes them susceptible to potential avalanches located further upstream; however, this does not alter their hazard ratings as they are presently at risk as well.

Chamlang South Tsho has very similar hazard characteristics to Chamlang North Tsho. Chamlang South Tsho is no longer expanding as it has already reached its fullest extent (Fig. 6). Mass movement trajectories also show that the lake is surrounded by unstable slopes such that any rockfall or avalanche will enter the lake (Fig. S2a, b). The SLA exceeds the stability threshold with a value of 10.5° , indicating that the moraine is unstable. Additionally, satellite imagery reveals the presence of melt ponds on the moraine, thereby suggesting the moraine is ice-cored (Fig. S2c), which has been verified from the differencing of multi-temporal high-resolution DEMs (Sawagaki et al., 2012; Lamsal et al., 2016). Therefore, the steep ice-cored moraine is considered to be a high risk for self-destruction. The combination of self-destructive failure and the potential for a dynamic failure classifies this glacial lake as a very high hazard. The MC-LCP GLOF model (Fig. S2e, f) also reveals 228 buildings and 2.5 km^2 of agricultural land are at risk (Table 7), so Chamlang South Tsho is considered to be a high risk.

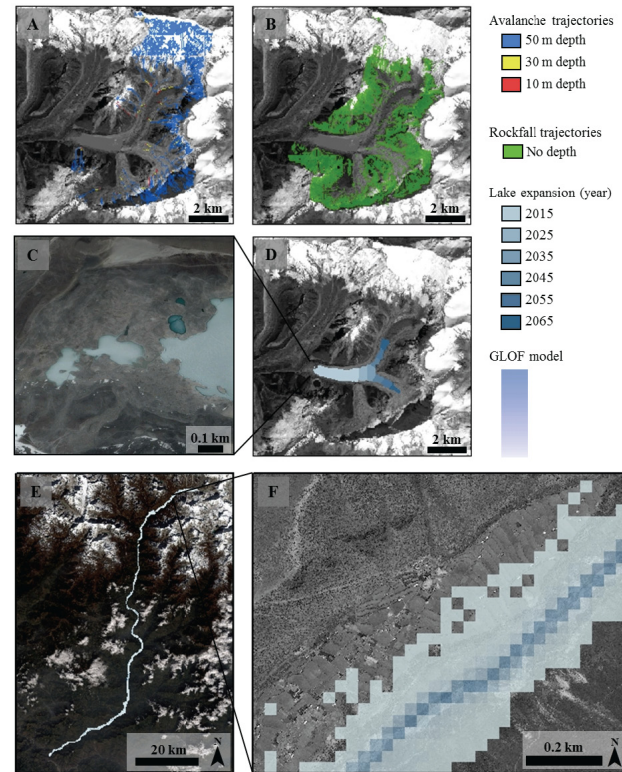
Figure 7. Hazards and downstream impact for Imja Tsho: (a) avalanche trajectories, (b) rockfall trajectories, (c) ponds on the moraine, (d) future lake expansion, and (e) the extent of the MC-LCP GLOF model (f) highlighting the impacts at Dingboche. The background image (a–e) is Landsat 8 from 30 September 2015 and (f) WorldView 2 from 7 June 2015 (DigitalGlobe, Inc.).

Imja Tsho is one of the most well-studied glacial lakes in Nepal, yet the remote hazard assessment still yields new relevant insight. The mass movement trajectories (Fig. 7a, b) show that the lake is currently not at risk of a dynamic failure. These trajectories are conservative estimates of avalanche and rockfall runout, and for a worst-case scenario they remain at least 800 and 400 m from the calving front, respectively. The ice thickness behind the calving front is greater than 200 m thick (Somos-Valenzuela et al., 2014; Frey et al., 2014), which allows the lake to continue to expand (Fig. 7d). A detailed analysis of the growth of Imja Tsho (Fig. 6) shows the lake is expanding at an average rate of $0.032 \pm 0.004 \text{ km}^2 \text{ yr}^{-1}$. Based on these expansion rates and the ice thickness estimates, the lake may be at risk of a rockfall entering the lake in 10 years and an avalanche entering the lake in 20 years.

6.8°. The melt ponds on the moraine (Fig. 7c) suggest the presence of buried ice, which has been confirmed in the field (Hambrey et al., 2008). The ice-cored moraine is currently not a large concern as its gentle slope does not produce hydrostatic pressure that endangers the lake. However, satellite imagery reveals the outlet lakes have been changing rapidly, which is important to monitor as these changes may alter the hydrostatic pressure on the moraine (Fujita et al., 2013). If the outlet lakes on the terminal moraine are considered to be part of the lake, the SLA changes to 11.0° and Imja Tsho would currently be a high hazard and high risk. Therefore, monitoring the development of the outlet lakes and their influence on the hydrostatic pressure should be a top priority. The MC-LCP model (Fig. 7e, f) shows that 539 buildings and 2.7 km² of agricultural land are at risk (Table 7), which corresponds to a high downstream impact.

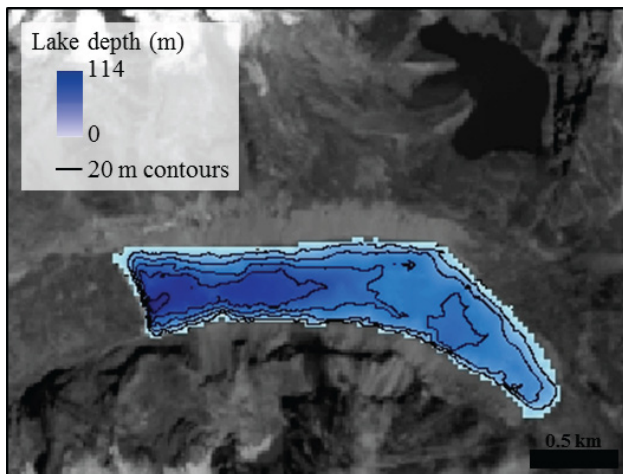
Figure 8. Bathymetric survey conducted on Lumding Tsho on 22–23 October 2015.

An initial rapid reconnaissance was undertaken from 20 to 24 October 2015 to assess the hazards associated with Lumding Tsho as directed by the management action framework (Fig. 5). The short field campaign consisted of a bathymetric study, streamflow measurements of the outlet, and visual inspection of the terminal moraine and surrounding slopes. The bathymetric survey was conducted over 2 days using an inflatable kayak and a Garmin echoMAP 54dv to measure 4768 points of lake depth. The shoreline was delineated using the NDWI methods as previously reported. The shoreline was converted into point measurements that were used in conjunction with the bathymetric survey to interpolate depth throughout the lake using the Topo to Raster tool in ArcGIS (Somos-Valenzuela et al., 2014). The lake was found to have an average depth of 51 m, a maximum depth of 114 m, and a total volume of $57.7 \times 10^6 \text{ m}^3$ (Fig. 8).

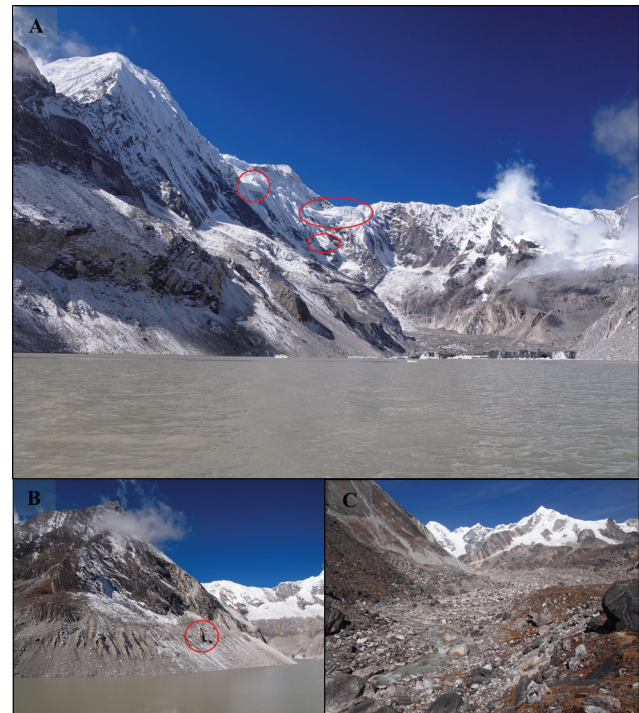
Figure 9. Lumding Tsho and its surrounding slopes with areas of concern highlighted in red showing (a) the calving front and prone areas behind the glacier, (b) the southern side slope, and (c) the terminal moraine and its gentle outlet.

Visual inspection of the side slopes revealed the slopes were very steep and likely lacked the ability to generate a large rockfall (Fig. 9a, b). On the southern slope there was one large boulder that could be a potential concern (highlighted in Fig. 9b), but its limited elevation above the lake level would likely cause only a small surge wave. The snow and ice above the southern side slopes were also very steep and no hanging glaciers were apparent. A more detailed assessment of the stability of the side slopes would be invaluable in improving the likelihood of a rockfall or avalanche. Specifically, the three hanging glaciers located behind the calving front (Fig. 9a) are potential hazards as the lake grows. Physically based mass movement models would generate important information regarding the size and trajectories of these slope failures. Unfortunately, due to time constraints, a detailed analysis of Lumding Tsho, the upstream
