SERIES IN ANTHROPOLOGY

CONTRIBUTIONS TO MESA VERDE ARCHAEOLOGY: I  
SITE 499, MESA VERDE NATIONAL PARK, COLORADO

ROBERT H. LISTER

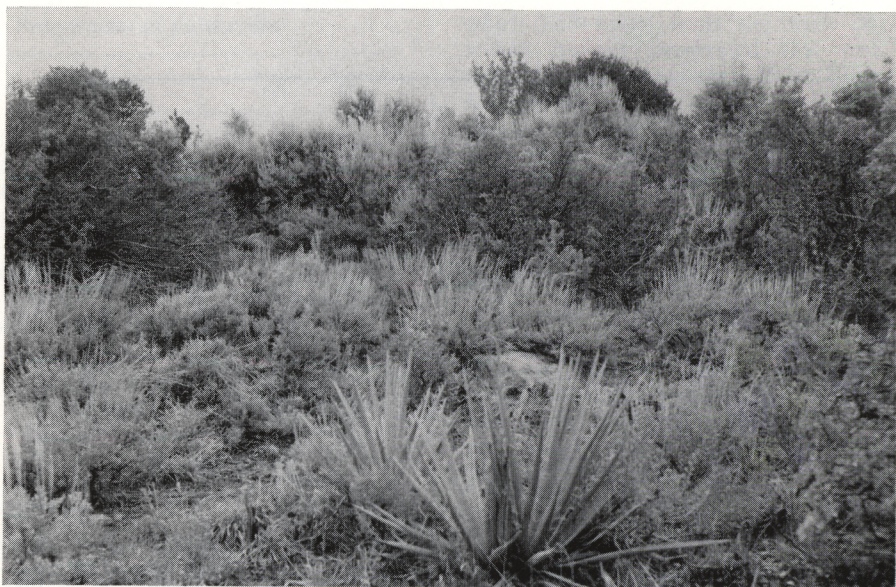
PLATE 1. Site 499, before clearing, looking northwest

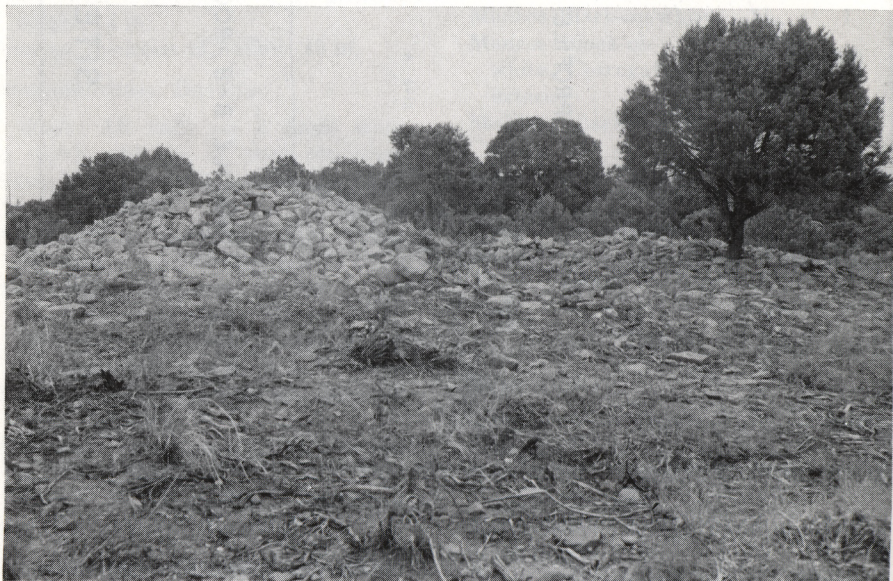
PLATE 2. Site 499, after clearing, looking northwest. Mound at left covers tower.

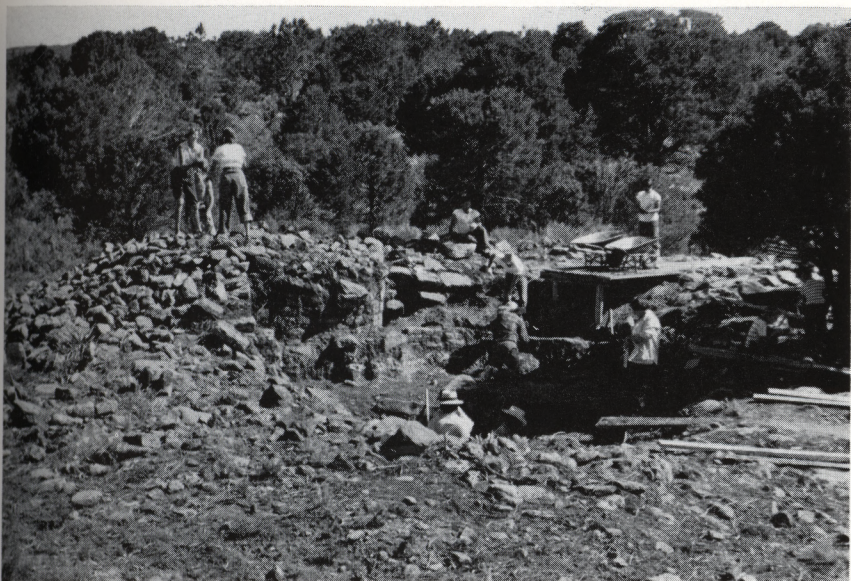
PLATE 3. Site 499, during excavation, looking north. Mound at left covers tower. Individuals in foreground working in Kiva B.

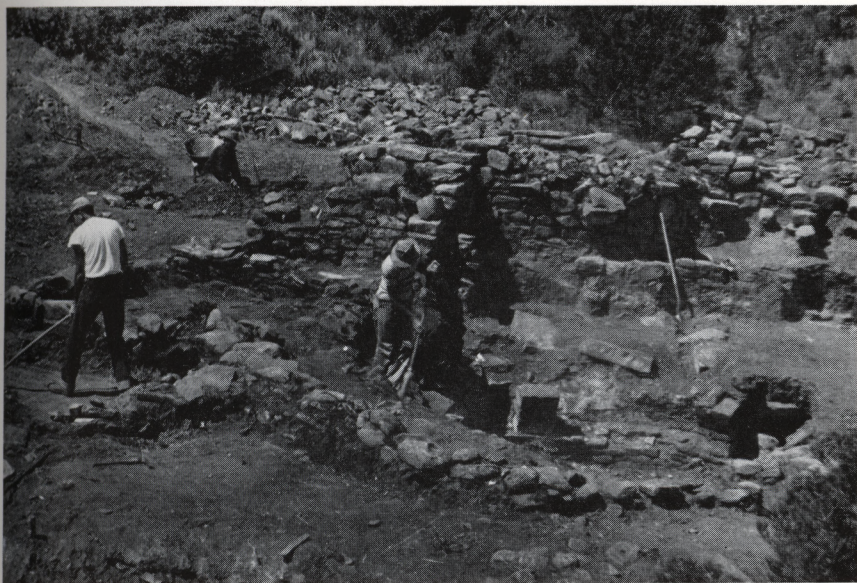
PLATE 4. Site 499, during excavation, looking north. Individual on left is clearing Room 9; individual in center is sweeping pilasters of Kiva B.

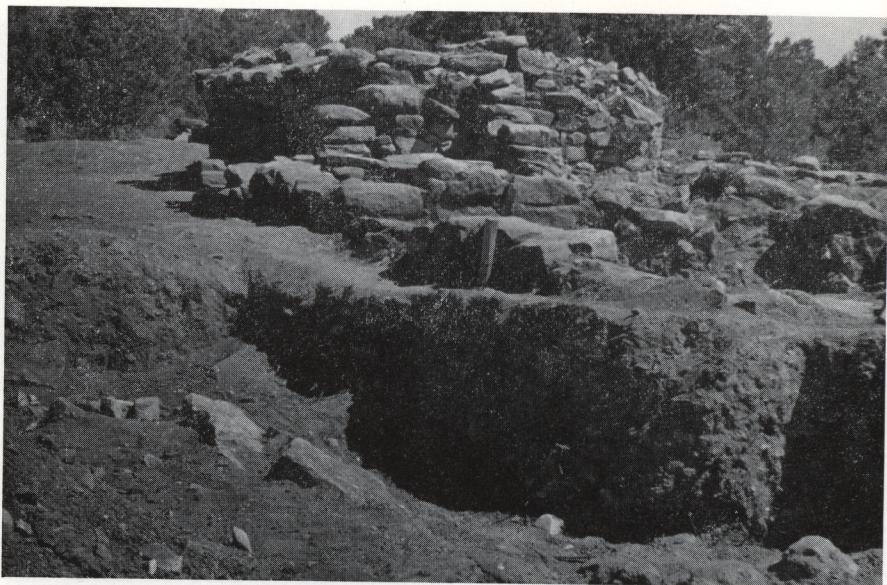
PLATE 5. Relationship of Trash Mound 1 to Room 9. Note depth of refuse and fact that foundation of Room 9 is built on the trash deposit. Tower in background.

South wall—fallen. Few, if any, of the stones are in original positions. The southern part of Room 9 was built over Trash Mound 1, a factor which probably contributed to the collapse of walls of that part of the room since the unconsolidated nature of the refuse would have served as a poor foundation for them.

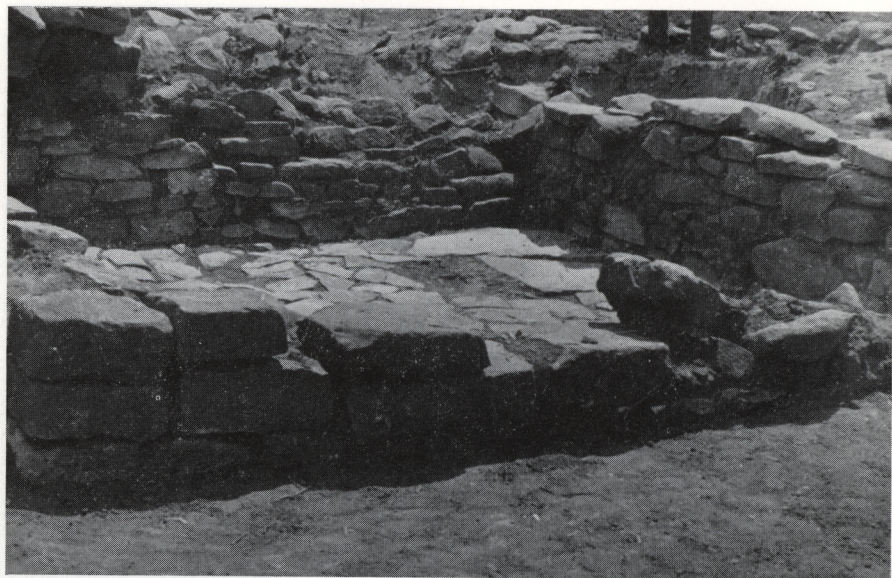
PLATE 6. Room 11, looking east. Note flagstone floor and fact that part of eastern wall has toppled outward as a unit.

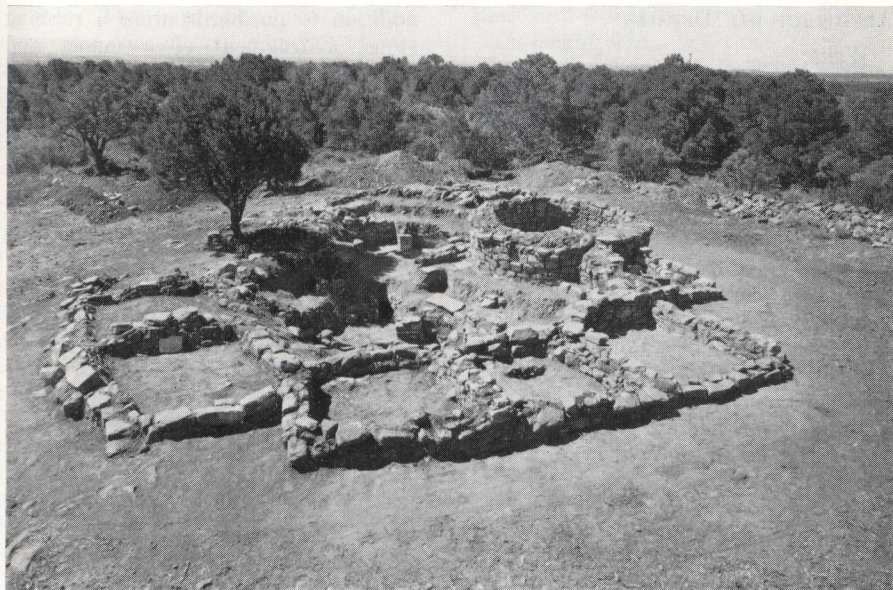
PLATE 7. Site 499, after excavation, looking south

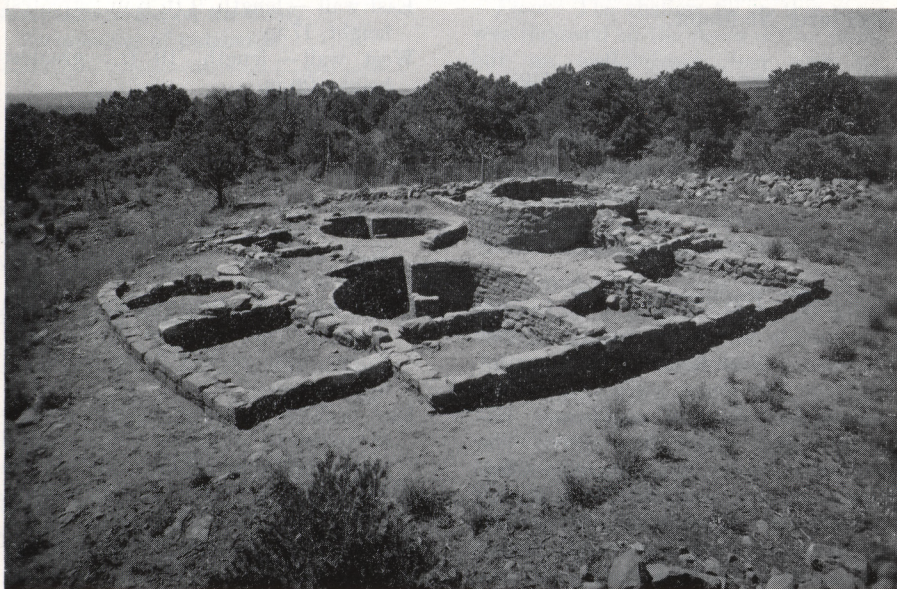
PLATE 8. Site 499, after stabilization, looking south

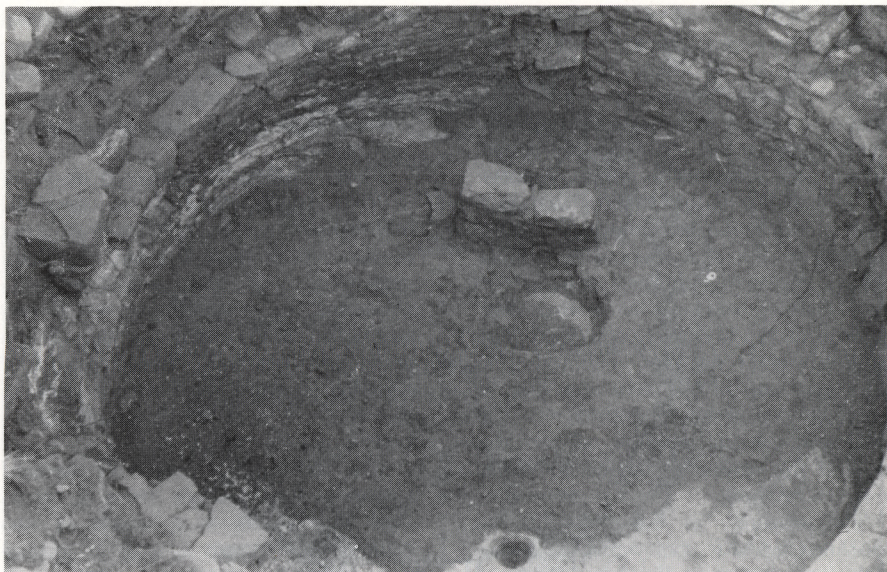
PLATE 9. Kiva A, looking south. Note sipapu, firepit, deflector, and unexcavated entrance to ventilator tunnel.

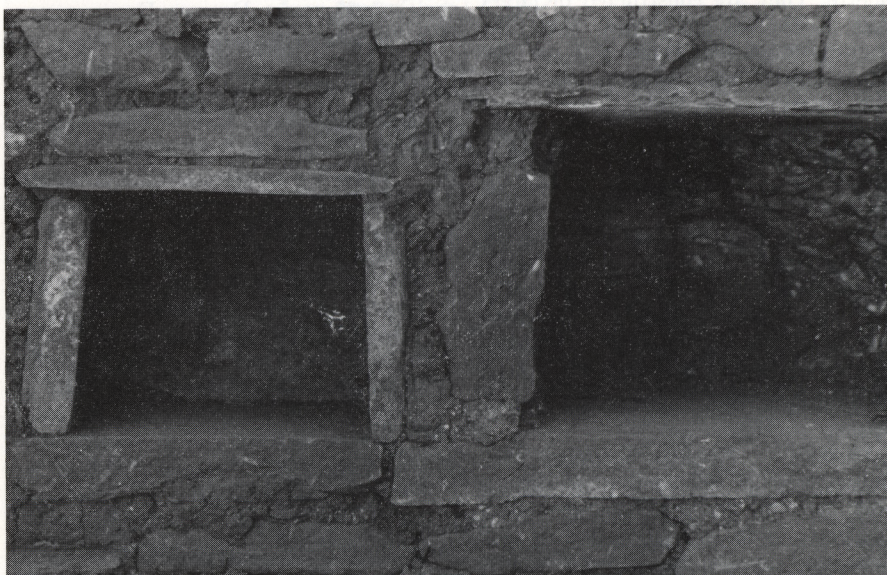
PLATE 10. Kiva A, Niches 3 and 4

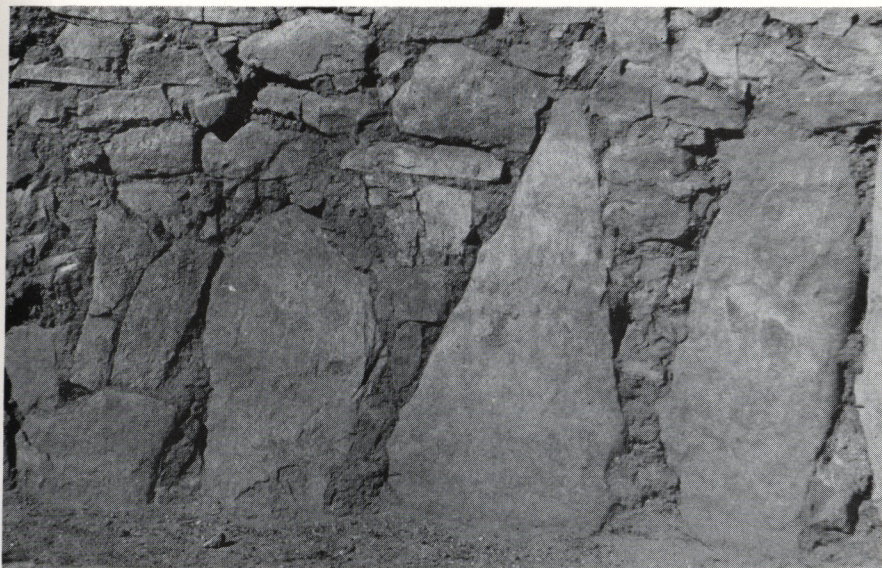
PLATE 11. Kiva A, base of banquette. Note use of vertical slabs and masonry.

*Walls and banquette:* The masonry of both the wall and the banquette of Kiva A is a combination of large stone slabs and coarse stone masonry. The bases of both banquette and wall above the banquette consist predominately of vertically placed slabs of sandstone. Areas between the slabs are filled with small spalls of stone. Above the slabs, coursed masonry consisting of sandstone blocks of varying sizes is present.

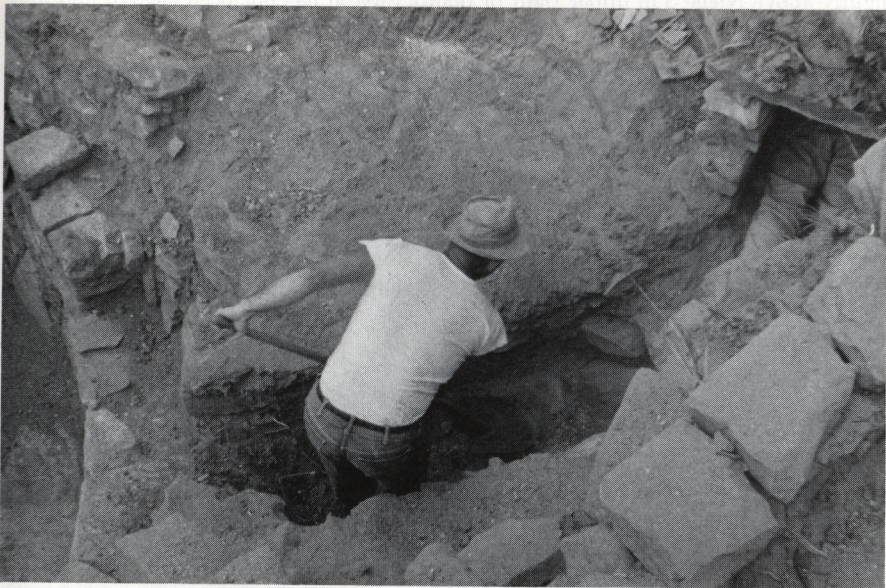
PLATE 12. Clearing passage between Kiva A and tower. Individual with shovel is standing in part of passage which was probably originally roofed with planks or poles. Note individual on right crawling into covered tunnel.

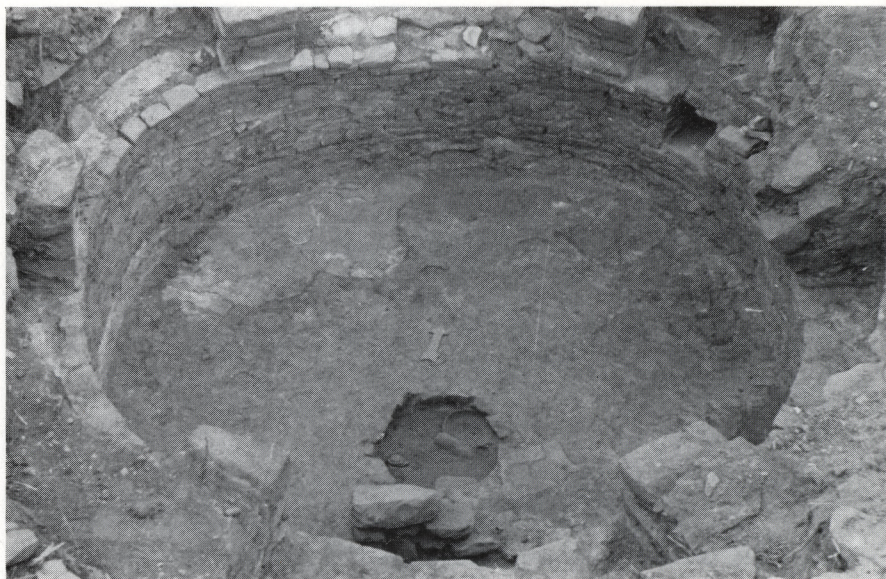
PLATE 13. Kiva B, looking north. Note entrance to tunnel leading to Kiva A slightly above Niche 3 in upper right of photo. Sipapu has not been cleared and fire-pit only partially excavated.

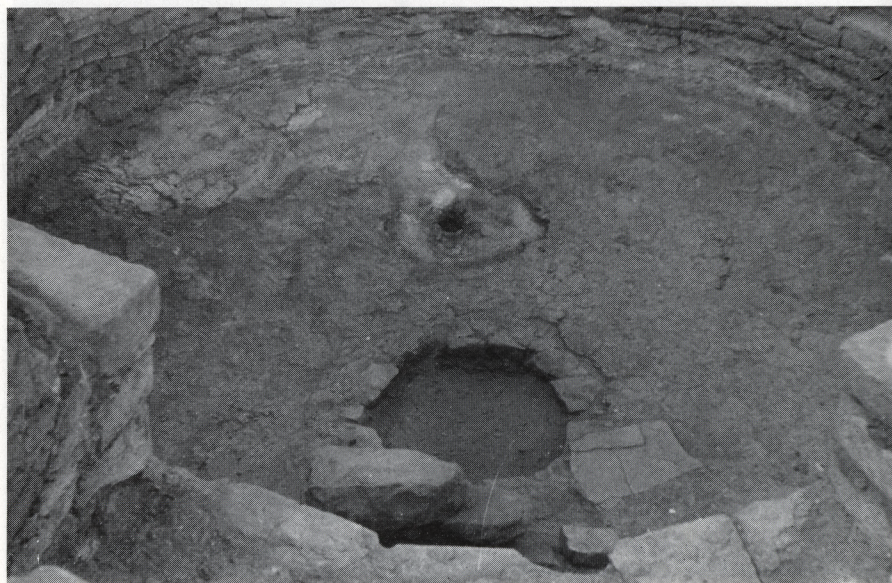
PLATE 14. Kiva B, looking north. Note deflector, firepit, sipapu, and plastered floor.

The deflector is built of masonry, a single stone in thickness. It stands four courses high. The firepit is circular in outline and completely lined with small stones. Several large sherds were found in the ashes in the firepit.

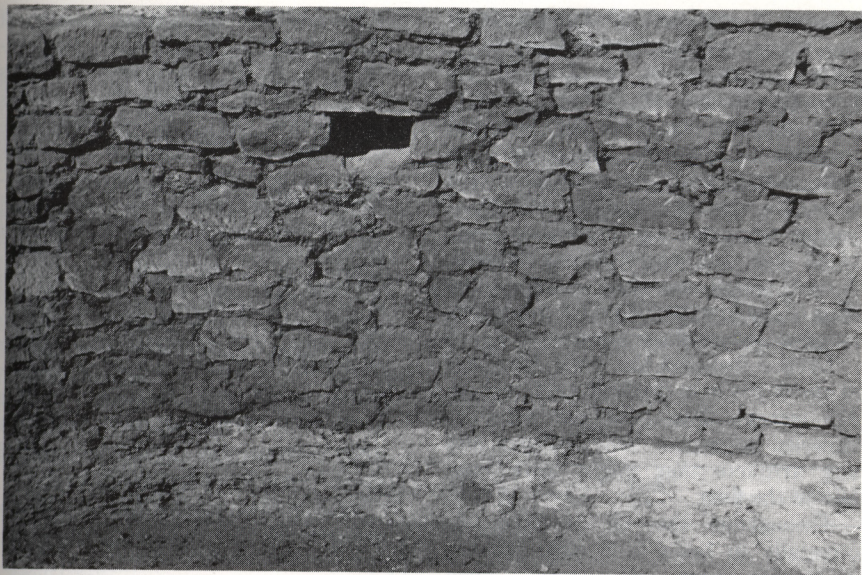
PLATE 15. Kiva B, banquette and Niche 1. Note complete use of masonry.

*Walls and banquette:* Coursed stone masonry is employed in both the walls and the banquette of Kiva B. Slab foundations are not used. As was the case in Kiva A, the banquette is fairly well preserved, but the tops of the walls have crumbled to a large extent. The wall above the banquette stands 2 feet 6 inches high in one place but elsewhere averages only 1 foot 7 inches in height. The masonry walls of the southern recess are similar to those of the remainder of the kiva. A floor of plastered mud covers the bottom of the southern recess.

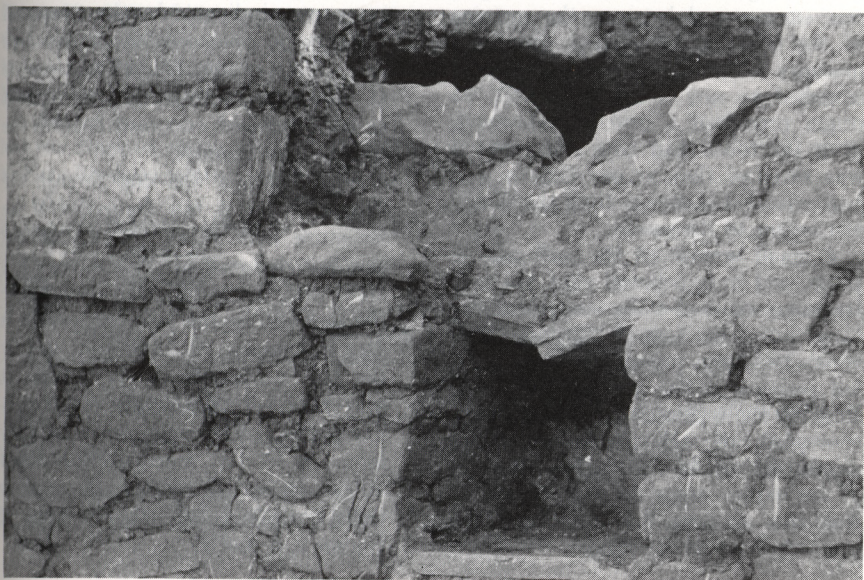
PLATE 16. Kiva B, Niche 3. Above it is opening to passage leading to Kiva A.

Four niches occur in the banquette. One is located just south of Pilaster 2, a second is between Pilasters 3 and 4, the third just east of Pilaster 4, and the fourth to the west of Pilaster 6. Three of them are small, and had been built by simply omitting a rock or two of masonry. The fourth (Niche No. 3) has a rear wall consisting of a stone slab and a thin stone lintel which has broken in half. It has a plastered floor of mud. All of the niches were empty when excavated.
